Earthquake & Tsunami Emergency Support Project

ETESP

Bireuen Kabupaten

Data Assessment & Soil Reclamation
(December 2005)
(With map updates of April 2006)

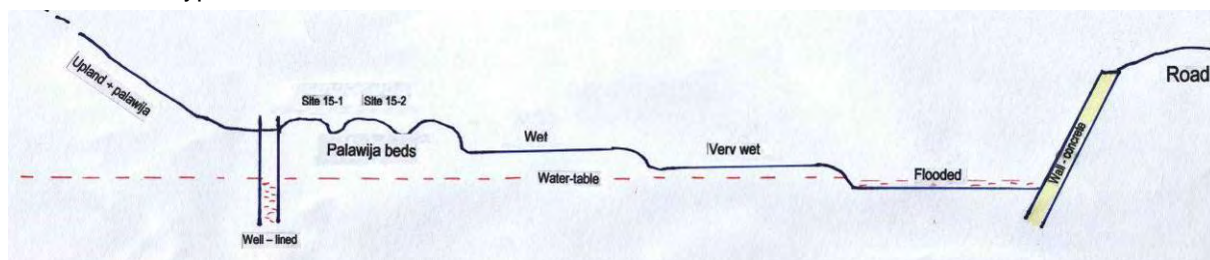
Cross Section of typical location

The soil is considered slightly to moderately damaged with salinity levels of 2-4 dS/m (Salinity Class SC1) with reclamation normally being attempted by the farmer without guidance. But, the farmers are only having limited success and that is normally only on the highest parts of their farm. The main problem with such sites is a high water table and restricted drainage. Water tables at highest part of farm are at 50-75 cm with salinity of 0.25-0.50 dS/m (Class C2) and the water table is usually at the surface on the lower parts of the farm.

1. High water table which gets closer to the surface as the level of the land falls towards the natural stream lines
2. The land in the lower-slope positions is flooded since the water table is actually at the surface
3. Man-made structures, such as roads, urban and agricultural drainage ditches and irrigation channels, acting as dams and blocking the drainage
4. Inappropriate, surface flow irrigation methods are being utilised and these are perpetuating the salinity
5. No in-field or on-farm drainage and natural stream lines are no longer active

1. Install in-field & on-farm drainage, these can be farmer-installed with guidance and instruction
2. Clear, unblock and restore natural drainage lines and ensure they connect to the local river or drain
3. Deepen in-field furrows so they can act as drains to remove any saline leachate produced – the farmer can implement this
4. Apply irrigation as overhead and not surface-flow, this will better enable soil leaching – use watering cans or appropriate, low-cost technology with piped or pumped supply
5. Use salt tolerant varieties and, for the immediate future, only grow palawija on raised beds with overhead irrigation techniques.

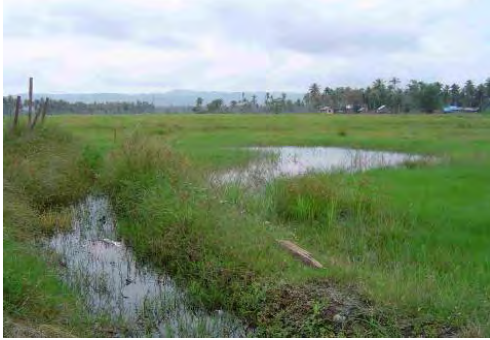
Typical site previously used for padi

The soil is considered to be moderately to heavily damaged and still flooded. Surface water salinity of 1.5-2.0dS/m (Class 3) and surface soil salinity of 4.63dS/m (SC2). However, previous irrigation systems are now acting as drainage systems and could be utilised to drain and reclaim this land if some refurbishment was done, channels cleaned and deepened to improve the outflow of the main drains or channels into the sea plus preventing or reducing tidal effects.

Sites like this are on almost flat alluvial plains with no obvious high points, still totally or partially flooded, no cropping at all and covered in grasses which are being browsed by buffalo etc. and are close to the coast. But, at least one location, there was an operational drainage channel. Refer the photos below. However, local information was that this was, in fact, a previous irrigation system. The in-field water-flow in this channel was fairly fast and there was an outlet into a major channel which was obviously linked to the sea. This drain or channel was flowing - but very slowly. This drainage system was governed by tidal movement and the local estimate was that there is presently between 50-100cm of sludge, sediment and rubbish in the channel or drain.

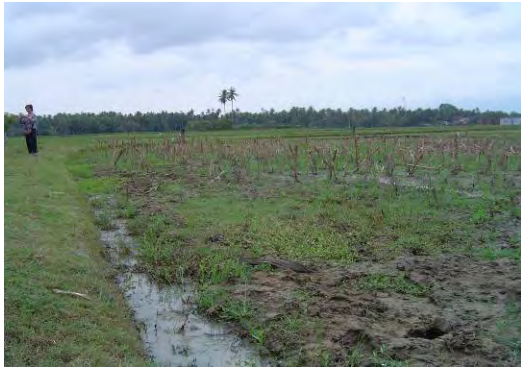
Raised bund above the soil drain

Level areas previously used for rain-fed rice but out-of-command of local irrigation systems and having the remnants of a soil drainage system. Soil salinity level about 4-6 dS/m (SC2) and water table at 30-50cm with salinity level of 0.3-0.6 dS/m (C2). Farmers have tried cropping but crops failed and sites now abandoned. Such sites can be quite badly damaged with the surface water virtually stagnant with algae etc growing and water is not passing into the existing drainage canal.

Much of the damage to such drains is not due to tsunami effects but is due to long-term neglect and lack of maintenance of the drain.

Clear the drain that passes through the site and also ensure it is cleared down-stream so that any effluent collected can be removed from the site. At the same time deepen the drain to below the rooting depth for palawija (50-60cm). Most of the on-farm work can be done by the farmers under guidance and through the “cash-for-work” scheme.

Establish, by digging, examining, describing and sampling soil profile pits in several locations within the site to establish if there is a restriction to drainage due to a plough pan. If there is a restriction deep plough or rip to at least 50cm depth to break or rupture any pan or restriction.

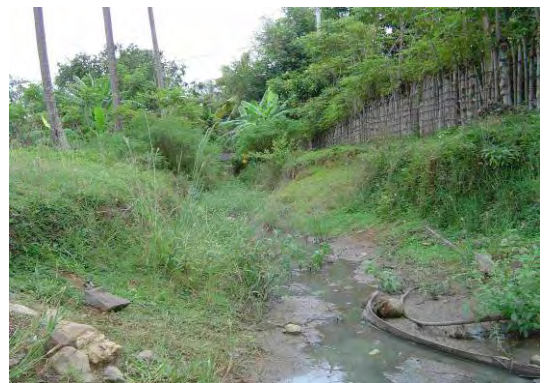
Badly damaged and blocked drain

Water is not entering the existing drain and it is suspected that there might be a plough pan formed over years of puddling with oxen.

Refurbishment will be mainly a civil engineering task and relatively expensive to implement but very necessary if not essential – not only for agriculture but also for social reasons.

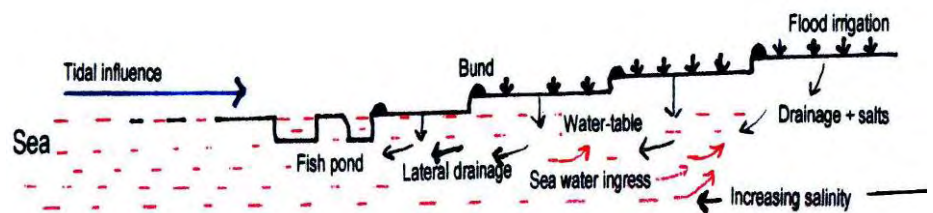
Salinisation of low lying site from the sea and irrigation

- Tidal influence and sea water ingress via the water-table, and
- Accumulation of salts in the lower slopes due to the sub-surface, lateral or sideways drainage of the soils further upslope. This is a natural phenomenon and is to be expected in any irrigation scheme, in particular where there has been inadequate provision of soil drainage

Salinisation is happening from the sea plus from the land and, for the worst affected areas, there is probably no way to reclaim the land and land-use should probably be changed to construction of fish ponds.

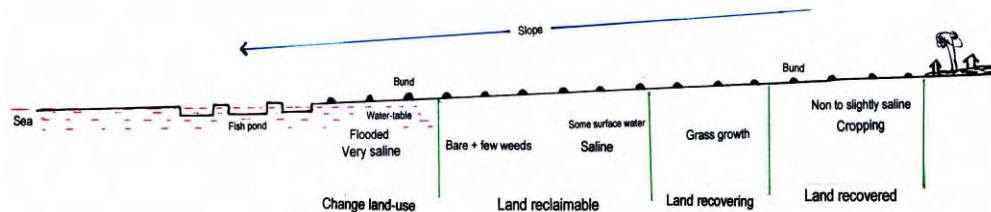
Cross section from village on high ground down-slope through padi area

The situation of this scenario is depicted on the right hand side of the diagram where the lower captions read “land recovered” and “Land recovering”.

Very little intervention is now needed on this scenario but, if there had been a more comprehensive drainage system, this land could have been back in production much sooner.

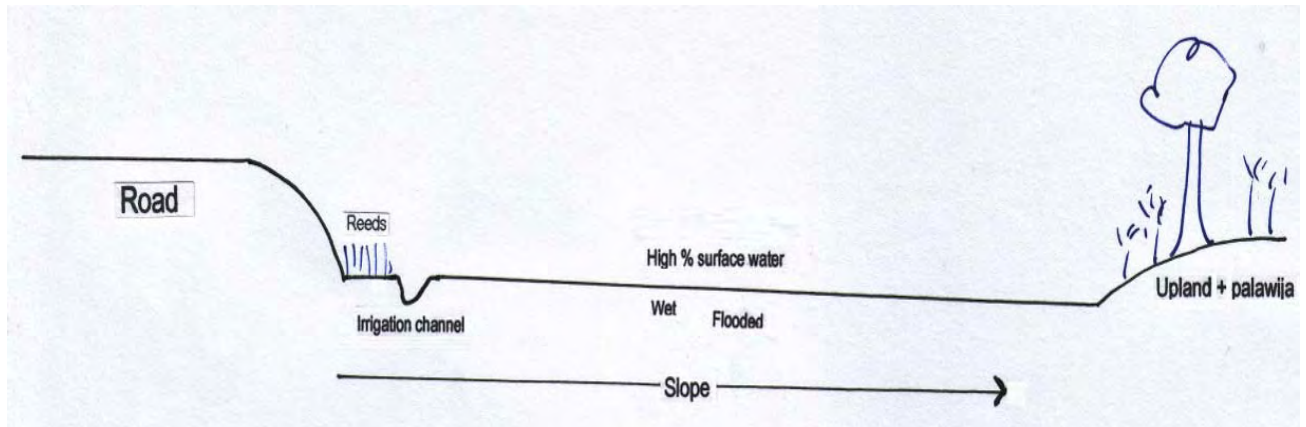
Figure 3.3 Cross Section of Site

Pre-tsunami the site carried padi and palawija in seasonal rotation with, reportedly, good yields. Presently there is no cropping, the area is covered in grasses and weeds on which buffalo were grazing.

The only significant conditions noted for this site was that the post-tsunami crop of corn failed and the site was then planted with rice.

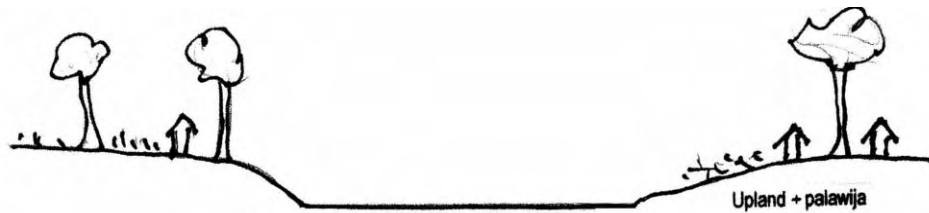
Figure 4.3 Cross Section of Typical Situation for Sites 8, 9 and 10

Site 9-1 also lies in an almost flat alluvial plain located between islands of upland and has an irrigation supply with water with EC of 0.05ms/cm. It was not established if this site had a drainage system or not but, as it was very close to the coast and there was a sandy, beach ridge it is possible that the site was draining naturally due to sub-soil sand layers. The farmer advised that he followed a padi / palawija pattern and his second crop since the tsunami was almost acceptable but was patchy and gave about 60% of predicted yield.

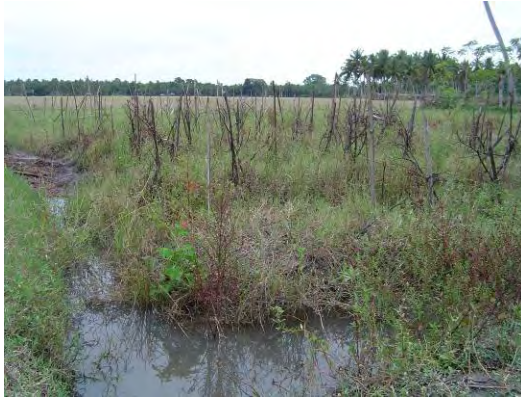
Figure 4.6 Dead Tomatoes

Site 10-1 also lies on an almost flat alluvial plain between dry-land high-spots and the site is very close to the coast and sea. There was an irrigation system but, being near the edge of the scheme, the farmer claimed that the supply was less than good and had very small delivery channels. There was also a drainage system but this was also poor and the main drain was clogged up with weeds etc. and the husbandry considered rather poor. The site was about 80% flooded and the standing water had an EC of 1.86ms/cm. The current crop was very poor in that tomatoes did grow but failed at the fruiting stage.

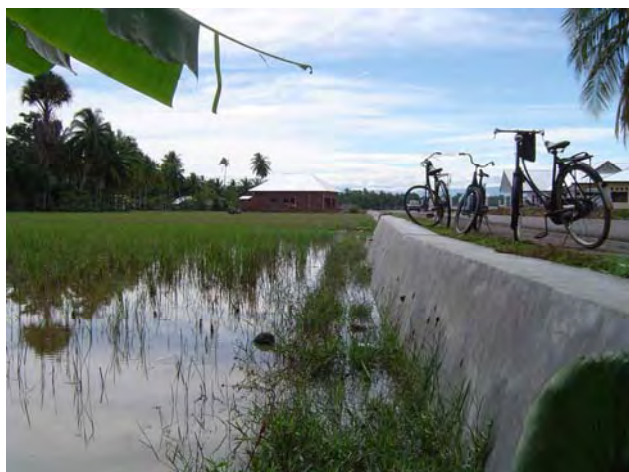
Figure 5.3 Road Dam Site 12-1

The site was totally flooded but the water rainwater as the EC was 0.01 mS/cm whilst the irrigation supply had EC of 0.18 mS/cm.. The land was presently being prepared for cropping and, in the past a padi / palawija rotation was used. The first post-tsunami yield was poor at about 50% but the recent crop gave about 80% of predicted yield so the land seems well on the way to recovery.

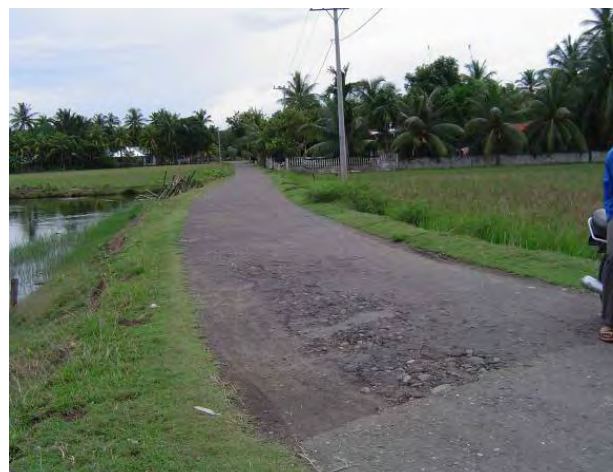
**Figure 5.4 Road + Site and Fishpond**

Site 12-2 was very close to 12-1 and is rather similar in that it is bounded on two sides by roads but the road is not, in this instance protected by a concrete wall. The third side of the triangular site is bordered by a wall at the edge of a village / upland area with dry land crops and trees. Over the road on the down slope side of the site there are fish ponds but it would appear that, in this instance the “road dam” is actually protecting the site and preventing tidal and or sea water ingress into the site. This site with the road, fish pond and upland dry land area can be seen in Figure 5.4. The site has the same irrigation water supply / drainage system as Ste 12-1 and the drainage is towards the fishponds but there does not appear to be an obvious outlet to the ponds.

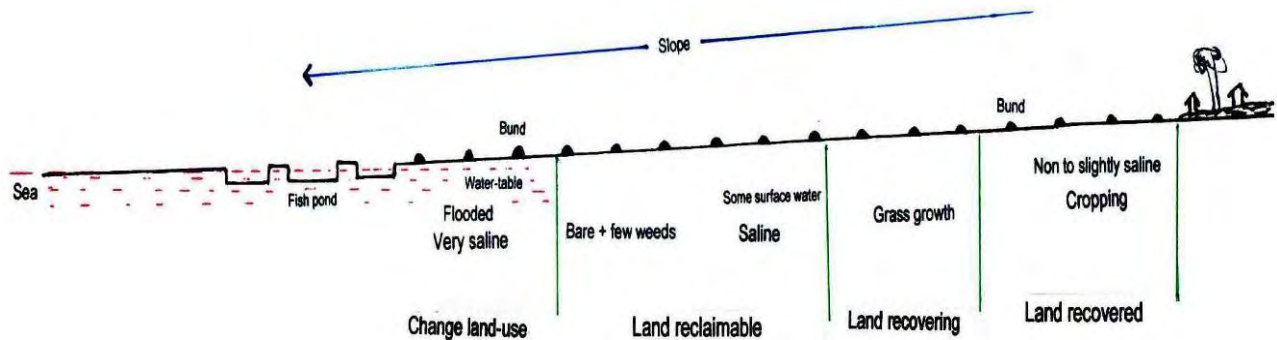
Figure 6.3 Down-slope Section for Site 11-2

Site 11-2 lies right at the top of the slope in an almost flat alluvial plain, located between islands of upland, and has the irrigation supply for this block of land as the upper boundary. The irrigation supply had water with EC of 0.01ms/cm. There was a drainage system but the first drains were, reportedly, quite far away down slope from the actual site. The farmer advised that pre-tsunami he could grow 2 – 3 crops of padi per year. There was no crop currently in the ground but the farmer stated that since the grass, growing on the site, was very even and very green he felt that it was now safe to plant his crops. Site 11-2 lies on the right hand side just below the dry land in Figure 4.3 in the area labeled ‘land recovered’ and as seen in Figure 6.6.

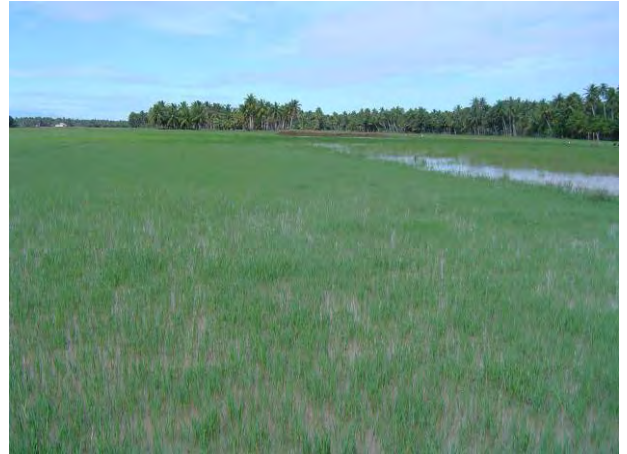
**Figure 6.6 Down valley over Site 11-2**

Massive reduction in yield post tsunami but now, almost one year on, the farmer estimates that the land has recovered – based on grass cover and condition. December 2005 salinity measurements by ETESP would appear to confirm the farmer's conclusion.
