## BLANG KREUNG SITE VISIT REPORT

***Kabupaten Aceh Besar***

## 1. Blang Kreung – site information

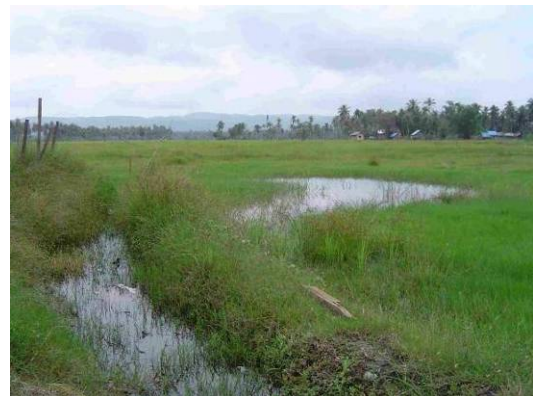
**Figure 1 Site at Blang Kreung**

Site 18 at Blang Kreung is on an almost flat alluvial plain with no obvious high points, mainly flooded, no cropping at all, covered in grasses. Figure 1.

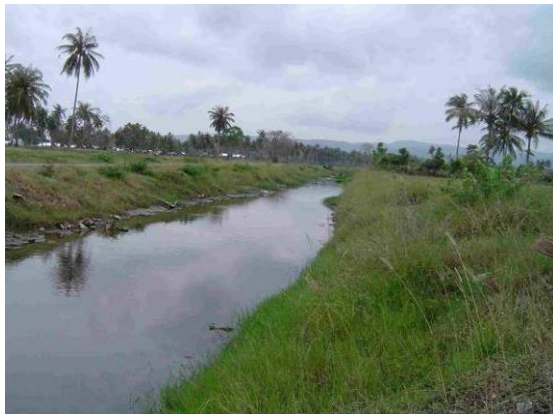
**Figure 2 Main Channel Site 18**

But there was an operational drainage channel. However, local information was that this was, in fact, the previous irrigation system. The water flow in this channel was fairly fast and there was an outlet into a major channel (Figure 2 and 3) which was obviously linked to the sea and this drain was flowing but very slowly.

This drainage system was governed by tidal movement and the local estimate was that there is presently between 50-100cm of sludge, sediment and rubbish in this channel.

It should be noted that this main channel is now tidal and the previous flood gates at the shore line were destroyed by the tsunami

The site at Blang Kreung can be reclaimed and the tsunami damage may have given the pointers for this. The previous irrigation channel is now acting as a drainage channel and water flow is relatively significant in the upper parts of this channel (Figure 3). The main, or lower channel (Figure 2) could be deepened significantly by removal of silt and garbage and, if it was, flow from Site 18 would increase and at least start the reclamation process.

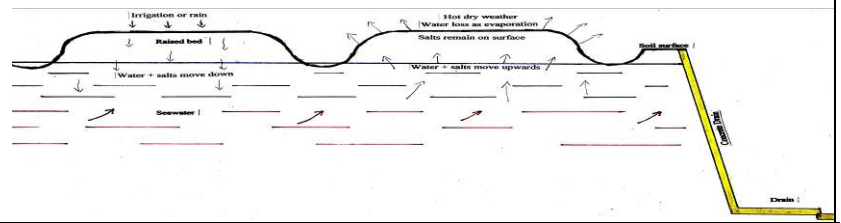
**Figure 5 Overhead Irrigation and Leaching**

With a raised bed there is an increase in soil depth and there is the possibility of leaching occurring via rainfall and, especially, if the farmer uses watering cans to apply any supplementary irrigation as an overhead system. This is roughly outlined in Figure 5

Very little can be recommended or put into operation until a soil drainage system is operational. As and when some soil is exposed it is recommended that raised beds are constructed and used for Palawija during the reclamation process.

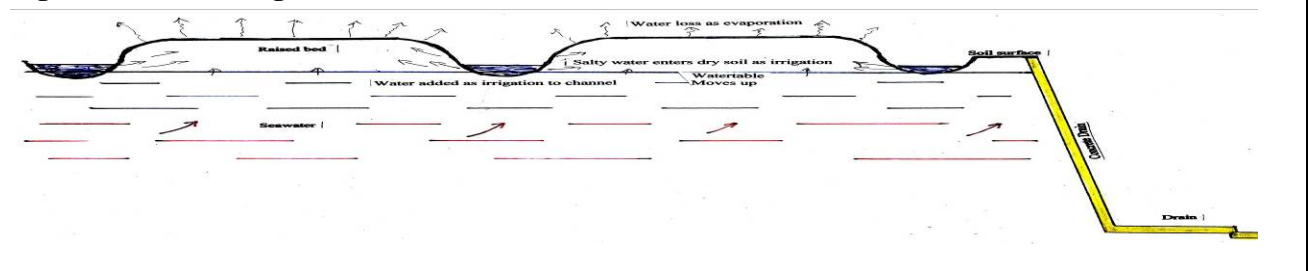
**Figure 6 Furrow Irrigation and Re-salinisation**

However, if the farmer uses surface methods of irrigation, such as in furrows, he will not be achieving any leaching and probably making the salinity problem worse. Refer Figure 6
