EARTHQUAKE and TSUNAMI EMERGENCY SUPPORT PROJECT (ETESP)

OXFAM SITES SOUTH OF CALANG

(March 2006)

VISIT TO OXFAM SITES SOUTH OF CALANG

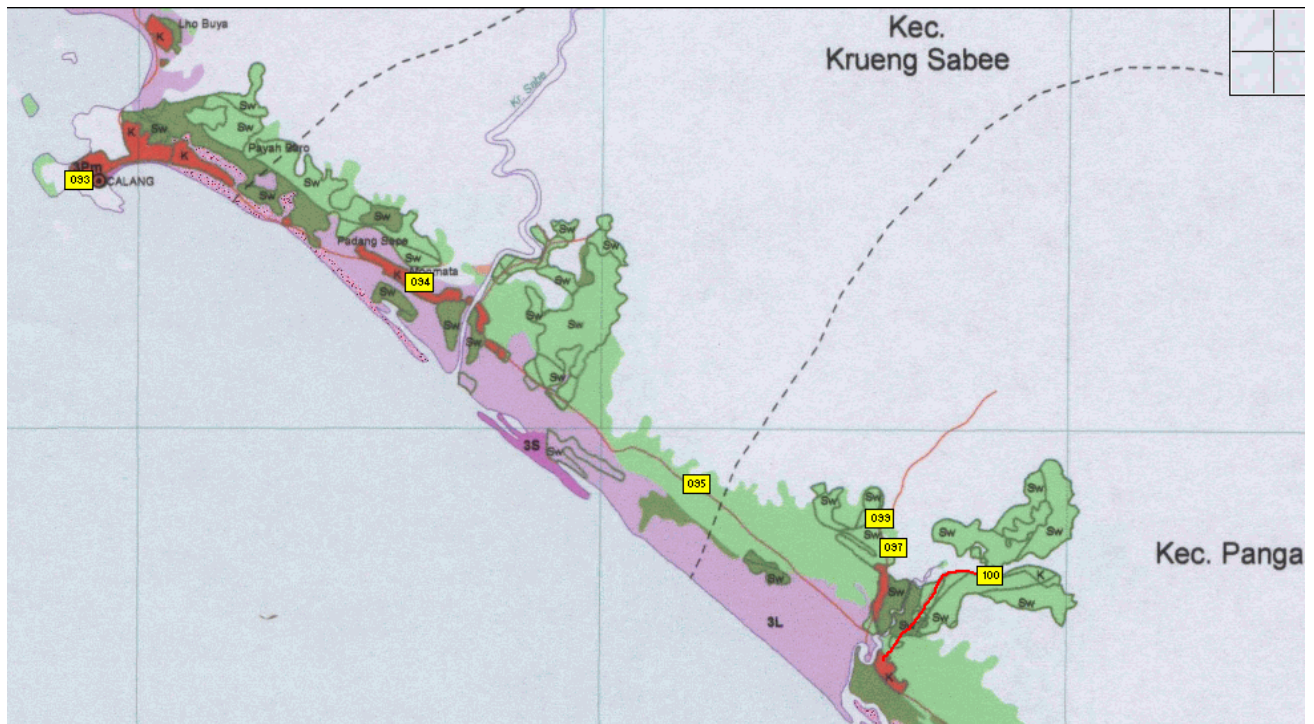
Figure 3.1 ISRI Soil and Land Damage Map with Waypoints of Sites

The damage has been recorded as slight and this was mainly from the salinisation of the soil from the sea water. However, as the areas in question (WPs 97, 99 and 100) were all previously used for rice cultivation the flood water became trapped in the fields – this is because rice fields are designed with bunds to retain the water that is added or applied to the site, whether that water is added by irrigation, rainfall or, as in this case, by flood. Being trapped on the sites the sea-water would then have infiltrated the soil and caused salinisation. This has now been recognized as one of the ETESP Scenarios; refer ETESP 2006 update of Scenarios.

As can be seen in the figure above the sites fall in the lightly damaged area and ETESP would agree with this classification.

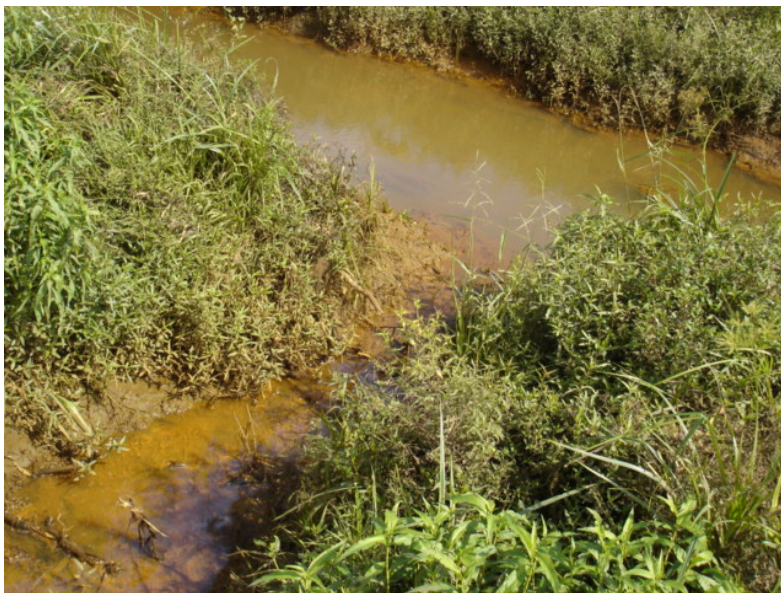
Figure 4.2 Side Channel Discharging into Drain

There is a well established drain running on the northern edge of this site and that drain, which was flowing quite strongly, leads and discharges into the local river. In addition, a small side channel was located within the rice and this side channel was discharging into the above drain. Refer Figure 4.2. This side channel may be erosional in origin but it is acting as a drain for a small section of the rice field.

To check and confirm the ETESP hypothesis that the problem is salinity and that this channel is acting as a drain several water salinity measurements were made using a portable salinity meter. Readings were taken every metre or so from the within the cropped area along this channel and it was found that the salinity of the water flowing in that channel was increasing as it progressed – indicating that it was gathering saline leachate from the field.

At the furthest point from the drain (furthest into the crop) there was an EC reading of just under 1.4dS/m, at the next point the reading was 1.47dS/m and near the end of the channel just before it discharged into the drain the reading had increased to 1.59dS/m – these are all high salinity class readings (Table 4.2). All these samples had a pH of 7, which is neutral.

Water salinity (EC) readings were also taken in the drain, upstream and downstream of where the side channel discharged:

- Upstream water salinity 0.06dS/m [low salinity water]
- Downstream water salinity 0.14 – 0.19dS/m [low salinity water, but significantly more saline than the upstream sample]
- Discharge area water salinity – very varied indicating that mixing was happening

If there were more side channels discharging into this drain then the salinity level would increase but, at present, very little saline leachate is entering the drain. In fact, this water could at present be used for applying to the fields of this site to help leach the salts out – the problem would be how to get the water raised from the ditch onto the field. Also, the

salinity of the water would have to be constantly monitored and the activity stopped if salinity increased to any great extent (a cut off when water salinity exceeded 0.5dS/m would be suggested)

This site is saline, there is a crop at the vegetative stage of growth and the prediction is that this crop will fail or return very low yield. As with the site at WP 97 the necessary intervention is the installation of field drains of about 100cm depth, discharging in to the existing drain. Refer Section 5.

- The first and immediate step must be the excavation of in-field drains to 75-100cm depth at, say, 50 metres spacing
- These in-field drains, dug into the soil and not lined in any way, should discharge into the existing collector drain that has been cleared / constructed at the edge of the block of fields

- Better bunds should be constructed round each field or plot to help ensure that any rain-fall that does occur stays on the field or plot and then infiltrates into the soil and does not run directly into the newly constructed in-field drains.

- The salinity of the leachate (water in the in-field drains) should be monitored regularly to check the salinity, as was done during the site visit with the salinity meter

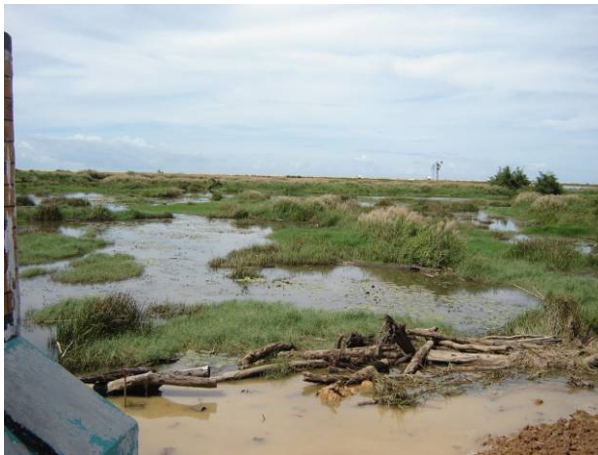
Figure 6.1 Clogged river

Another, related problem affecting this area and, in fact, most of the west coast is the state of the river channels. In many places the river channels are blocked or flow is badly restricted due to the amount of debris in the rivers. The debris comprises:

- trees and other plant material, part of the legacy of the tsunami
- non-vegetative material such as parts of bridges, houses and other structures
- silt, sand and other soil materials being trapped by the above debris

The effect of this debris is that the river flow is vastly reduced or stopped all together and often the river is considerably wider than it was and often flooding the land through which it flows. The knock-on effects are that the river is no longer able to transport water from upstream – and this water will contain the saline leachate from the sites that are being reclaimed – and remove the dissolved salts from the land by transporting them back to the sea.

If the rivers were flowing as they used to they would be greatly assisting the recovery of the land by removing any saline leachate that is discharged into them from drains, as it is the flooded areas will be slowly becoming more saline.

- clearing any sand-bars at the mouth of the rivers where they discharge into the sea – this has been previously mentioned in ETESP reports. This would be a major task and would involve the use of dredgers which would gain access via the sea
- once the river mouths were cleared the same action would be required back-up the course of the river – that is the main river channel deepened by dredging
- at the same time all debris would need to be removed from the river-course to enable normal river flow to resume

Some competent body should consider compiling a proposal or concept note as to exactly what is required; each river will be different so a separate document would be required for each location. The proposal or concept note would then have to be brought to the attention of some funding agency in the hope that funds could be found or made available to, at least, carry out a feasibility study.
