Earthquake & Tsunami Emergency Support Project

ETESP

Pidie Kabupaten

Data Assessment & Soil Reclamation
(December 2005)
[maps updated April 2006]

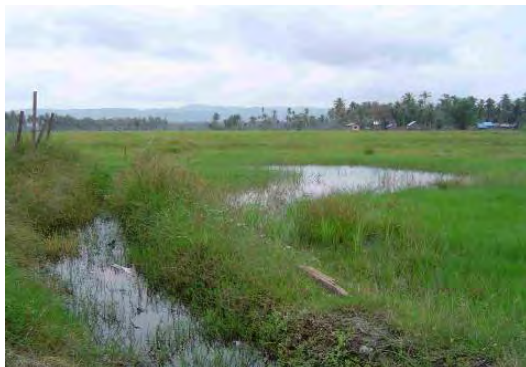
Typical site previously used for padi

Sites like this are on almost flat alluvial plains with no obvious high points, still totally or partially flooded, no cropping at all and covered in grasses which are being browsed by buffalo etc. and are close to the coast. But, at least one location, there was an operational drainage channel. Refer the photos below. However, local information was that this was, in fact, a previous irrigation system. The in-field water-flow in this channel was fairly fast and there was an outlet into a major channel which was obviously linked to the sea. This drain or channel was flowing - but very slowly. This drainage system was governed by tidal movement and the local estimate was that there is presently between 50-100cm of sludge, sediment and rubbish in the channel or drain.

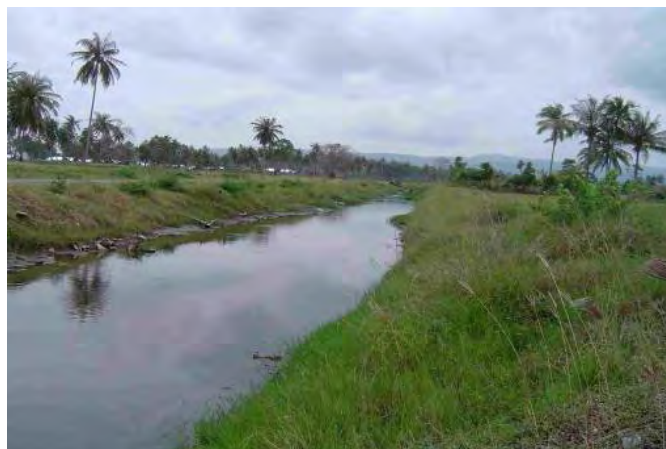
Existing badly silted-up channel

Deepen and clear all existing channels on, around and above the site, ensure all sediment and garbage is removed. Much of this can be done by the farmers under supervision and within the "cash-for-work" scheme.

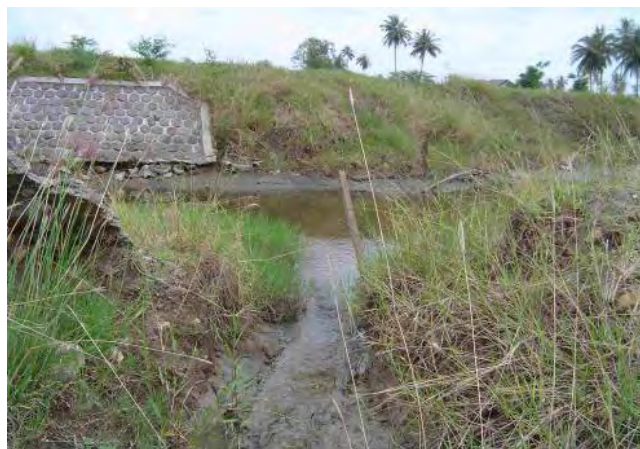
Drainage entering main channel

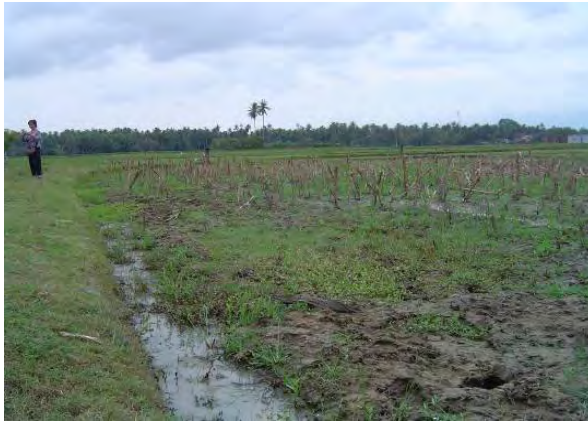
Level areas previously used for rain-fed rice but out-of-command of local irrigation systems and having the remnants of a soil drainage system. Soil salinity level about 4-6dS/m (SC2) and water table at 30-50cm with salinity level of 0.3-0.6ds/m (C2). Farmers have tried cropping but crops failed and sites now abandoned. Such sites can be quite badly damaged with the surface water virtually stagnant with algae etc growing and water is not passing into the existing drainage canal.

Raised bund above the soil drain

Clear the drain that passes through the site and also ensure it is cleared down-stream so that any effluent collected can be removed from the site. At the same time deepen the drain to below the rooting depth for palawija (50-60cm). Most of the on-farm work can be done by the farmers under guidance and through the “cash-for-work” scheme.

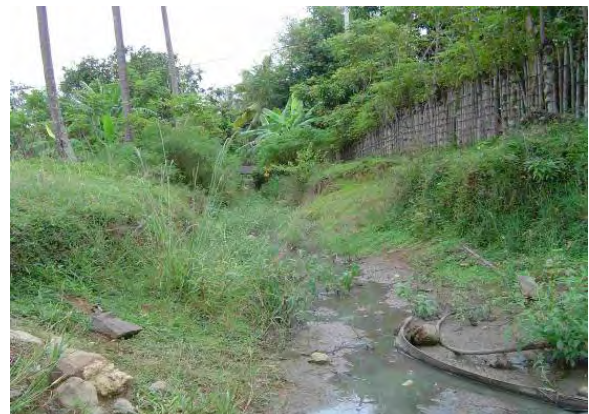
Badly damaged and blocked drain

Refurbishment will be mainly a civil engineering task and relatively expensive to implement but very necessary if not essential – not only for agriculture but also for social reasons.

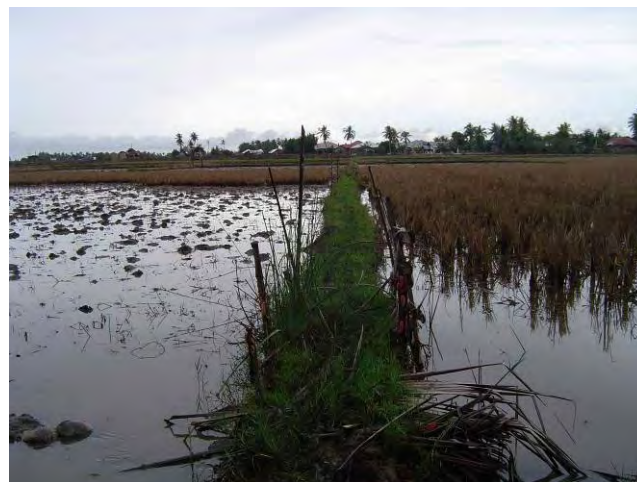
Figure 2.4 Rice Stubble and Recent Puddling

This site would fit the ETESP Scenario 4 situation since it is low lying, still flooded to some degree, close to the coast and abuts fishponds whilst there is irrigation supply. The main visible problems at this site are high water table, risk of inundation or intrusion with / by saline water from the sea and fish ponds plus lack of adequate soil drainage.

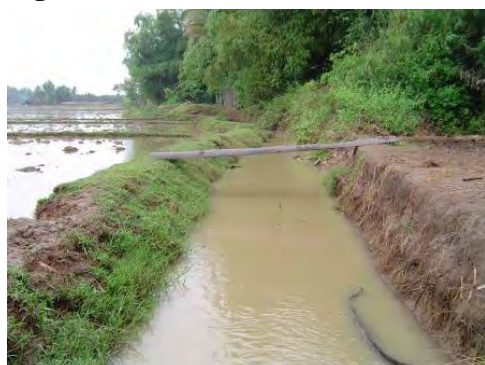
Figure 3.5 Collector Drain

The drain at this site in Cot Leue Rheng is fully operational with a good flow and is obviously draining the fields or land further up the valley.

However, the same drain could well be adding to the flooding and salinity at the sites at the lower end of the valley. The process involved is described in the ETESP paper "Scenarios".

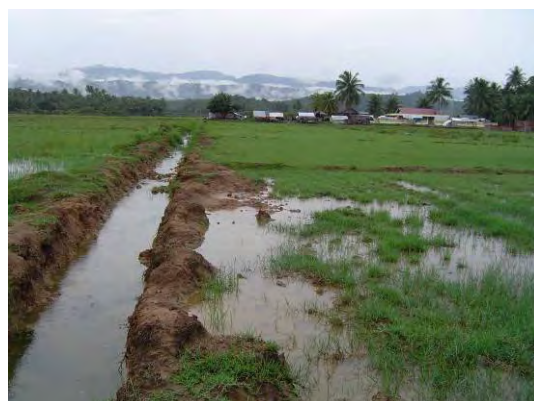
Figure 4.3 View over Site from the Highway

The water in this channel was flowing slowly towards the road where there was another channel or drain running parallel to the road.

However, there appeared to be no outlet or bypass to allow this water to get past the road and into the Nipa or mangrove area which lay on the north side of the road. If the field-drain was flowing more quickly and able to discharge to the mangrove area then desalinisation of Site 7-1 / 7-2 would be more efficient.

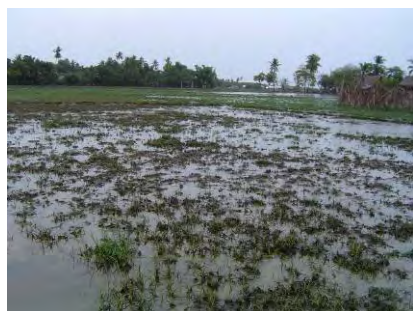
Figure 5.3 Across Site 3-1

Site 3-1 at Cot Jaja (Tungoe was not the correct name as noted during the EM38 survey) was at the edge of the village on a virtually flat alluvial plain and was adjacent to fish ponds very close to the coast. There was an irrigation system but no drainage system for the site. Standing water covered about 60% of the surface and this water was very saline at 15.6mS/cm. pre-tsunami this site was favoured for padi but currently, and since the inundation, cropping is not possible.
