EARTHQUAKE and TSUNAMI EMERGENCY SUPPORT PROJECT (ETESP)

RED CROSS SITE – LAMBADEUK, ACEH BESAR

(March 2006)

VISIT TO RED CROSS SITE LAMBADEUK WEST OF BANDA ACEH

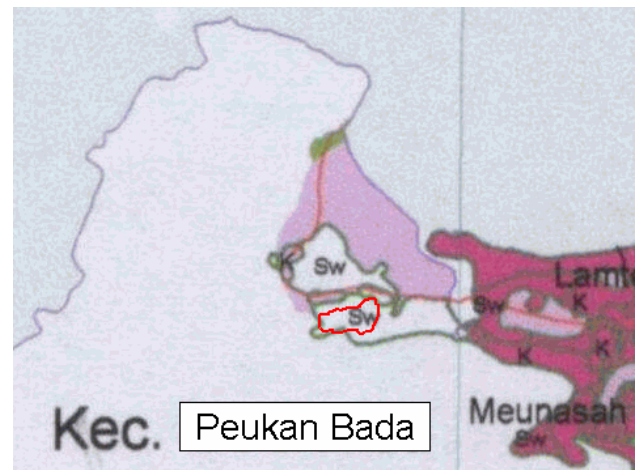
Figure 2.1 ISRI Soil and Land Damage Map

As can be seen in the figure above the site falls in the area which carries no colour and this indicates no damage at all or, so lightly damaged that it is considered negligible. ETESP does not totally agree with this classification (Refer Section 2.2.2).

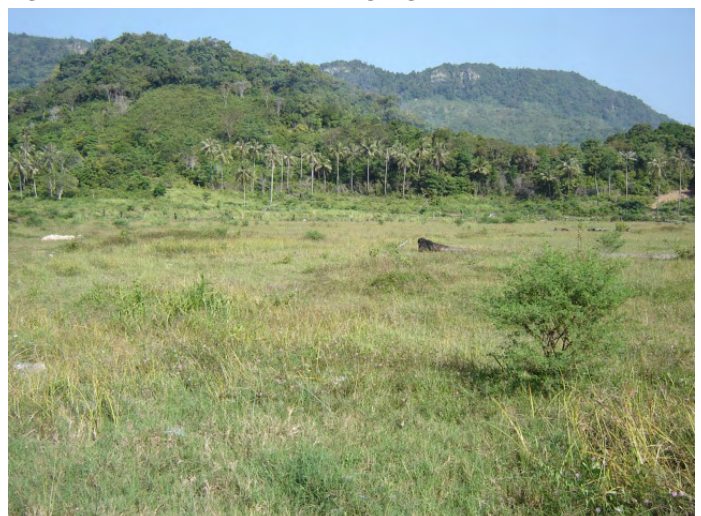
Figure 2.2 View Across the Site Showing Vegetative Cover

There was relatively good vegetative cover over most of the site, apart from some of the sand covered areas, and the vegetation was of mixed species. In other recently visited areas the vegetative cover has been a reliable indicator as to whether there is a salinity problem or not.

It is concluded that there is not a salinity problem on this site and that the lack of vegetation on the sandy areas would be due to poor moisture availability for plant growth since sands have low available moisture holding capacity (AWHC).

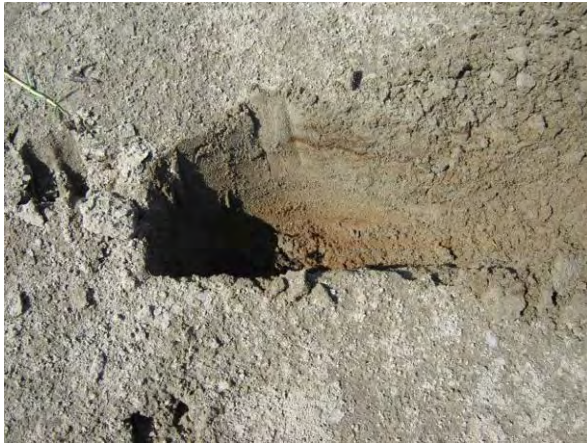
Figure 2.3 Grey Coloured Sandy Deposits on Reddish Soil

Reference to Figure 1.2 shows that a large portion of the eastern part of the site has a covering of sandy deposits or sediments.

There are sandy deposits on this site and these deposits have to be investigated further and their depths, extent plus spatial distribution mapped out.

Before other interventions are installed it would be very advisable to have a rapid survey carried out by a soil surveyor to map the distribution and depths of these sandy deposits. This does not need to be a formal soil survey with full profile descriptions but the aim could be accomplished by an auger survey making note of depths of natural horizons or layers defined by soil colour and / or soil texture. Suggested numbers of points to be described are detailed in Table 3.2 below, this table is one of the ETESP tools and the calculations are based on size of area and density of sites required to achieve various reliability levels of mapping.

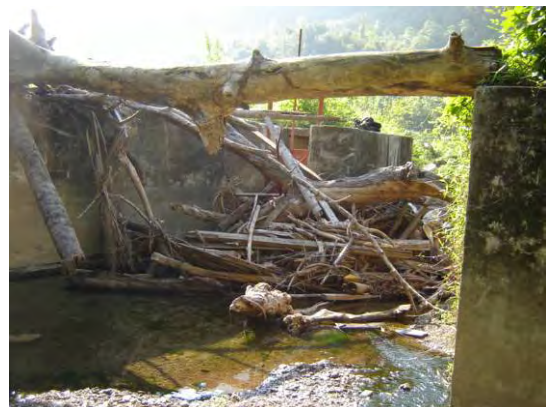
Figure 2.4 Debris in the Off-take

Prior to this visit the Red Cross had cleared the off-take of debris and had repaired the sluice gate. However, subsequent rainstorms have caused the river to carry high volumes of water with the result that much more debris has now collected in the settling pond and partially covers the off-take.

The concrete wall of the actual dam is also badly damaged meaning that the water level in the pond will possibly not be high enough to ensure a reliable water supply enters the irrigation canal. This wall has to be repaired and even made higher if necessary.

It is suspected that perhaps the irrigation system was not fully operational before the tsunami struck and it is not easy to determine if the damage to the off-take settlement pond was tsunami inflicted or not – whatever the cause some major engineering inputs might well be required to get this system operational again. At present the bed of the river channel is a long way below the off-take sluice gate and some engineering advice might be required as to how best ensure the system could trap sufficient depth of water to enable it to enter the irrigation canal. In addition, the wall of the dam has been breached and the whole structure may well have been weakened. Advising on the required interventions is beyond the capabilities of the Soil Specialist but the Irrigation & Drainage Component of ETESP might be able to offer some technical advice.

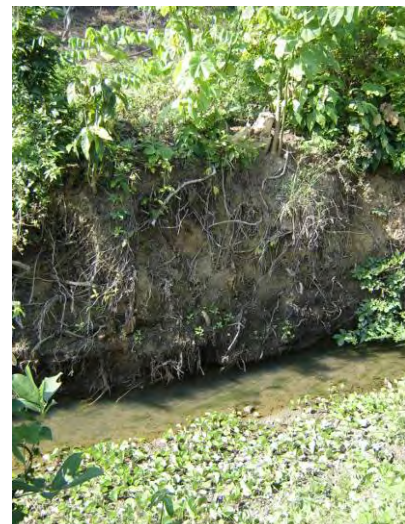
**Figure 2.5 Old Earth Main Drain**

• Main drain (earth)	Just outside the fence along the lower, southern edge, there was a large, 2 metre deep drain which was functioning. This drain appeared to discharge into the main drain or river, but this is assumed as the drain was not followed to where it joined the main drain.	The earth main drain did not show any obvious, major impact effects from the tsunami. But the full length of this drain was not inspected

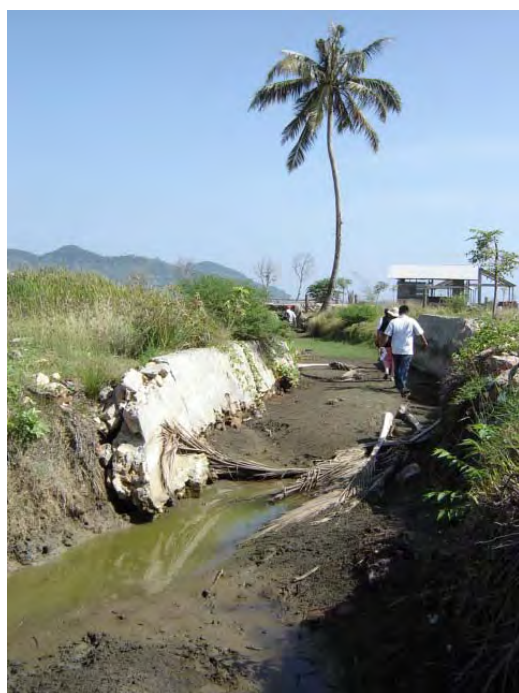
Figure 2.6 Up-slope in Main Drain towards the Sea

• Main drain (concrete)	There was a substantial concrete drain running north-south on the eastern edge of the area from WP 118 on the road. This drain was deeper at the southern end than the northern (ocean) end, depth ranged from about 75cm to over 150cm. The depth was limited near the northern end with some debris and a lot of sediment.	The concrete was broken and damaged in several places along the upper reaches of this drain. In some places the concrete had been “under-cut” – that is the soil material below the concrete had been eroded out. The sediment has reduced the operational depth of this drain

This “main” drain must drain in two directions since, as pointed out earlier, the land on this site slopes away from the sea – that is it slopes inland. At some point there must be a high point, or watershed, in the drain where there is drainage flowing in two directions; inland and towards the sea.

This subject has been discussed sufficiently above and further comment is beyond the capabilities of the Soil Specialist. A competent drainage engineer should be consulted and perhaps the Irrigation and Drainage Component of ETESP could offer some advice.

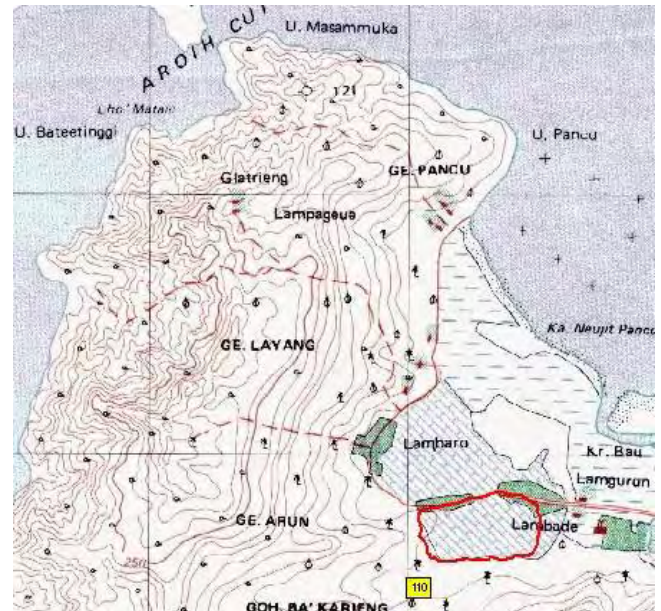
Figure 2.8 Site Protected by Headland

The main tsunami wave approached Sumatra from the west and in Figure 2.8 it can be seen that the Red Cross location plus the surrounding area was shielded from the full force of the wave by the hilly headland.

Once the wave reached the eastern shore of the headland its direction of approach would have been altered to quite an extent and perhaps it made landfall almost parallel to the coast. This would explain why the immediate shoreline was wrecked but lighter damage was suffered less than a few hundred meters inland.

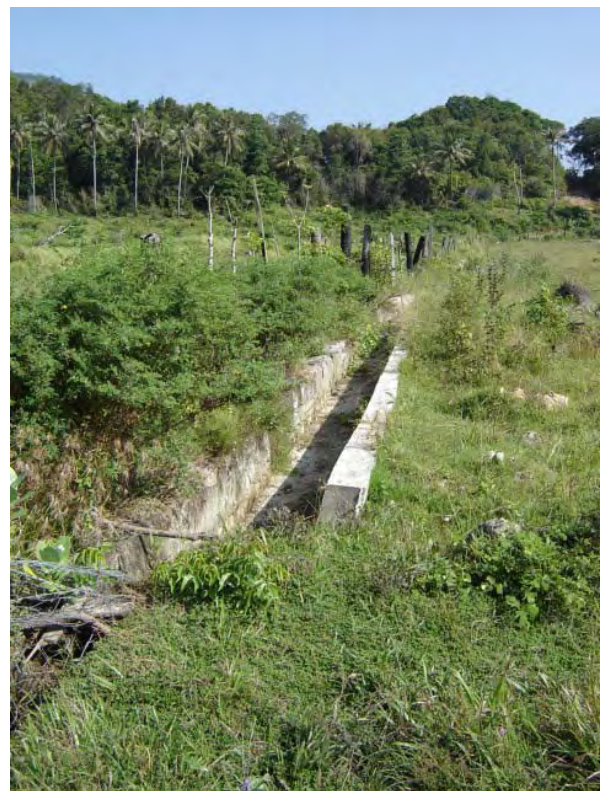
Figure 2.6 New Drain

From near the water tank (WP 111) this drain had been refurbished but it had been rebuilt with concrete, in fact at first the Soil Specialist assumed this was an irrigation channel. As it is installed at present this drain will act as a surface-water drain only and will actually reduce the amount of water that will infiltrate into the soil – plus it will not be able to remove any excess water from the sub-soil.

No more concreting should be done but what has been constructed should remain in place but field edge bunds must be constructed (Figure 2.5) to ensure that any water that does enter the field is allowed to infiltrate and not immediately drain away by flowing directly into the drain.
