EARTHQUAKE and TSUNAMI EMERGENCY SUPPORT PROJECT (ETESP)

Field Tour Report

Feb 20th – Feb 24th 2006

(Version of 6 March 2006)

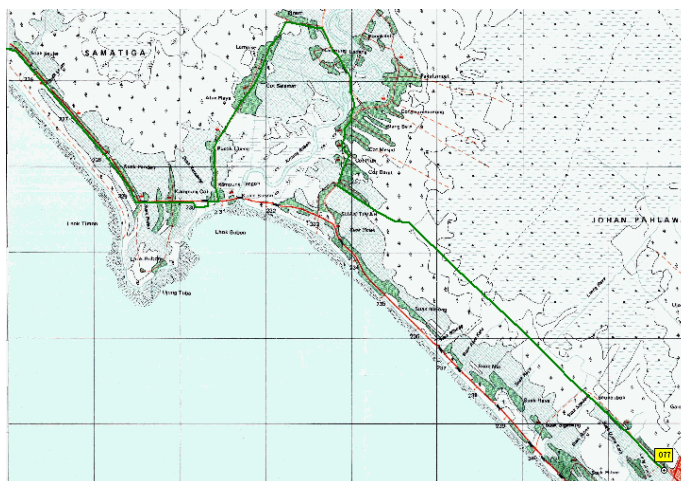
Figure 3.3 Final Part of the Route into Meulaboh

Very few observations made on this section due to light conditions – it was dark! However, it can be stated that the road was far from good with many off-road detours inland and sometimes onto the beach.

In Figure 3.3 the original road alignment is the red line whilst the route now used is the green line (GPS track).

As can be seen the present route generally lies almost 1km inland from the old route and very long detours are used to bypass badly damaged or flooded areas.

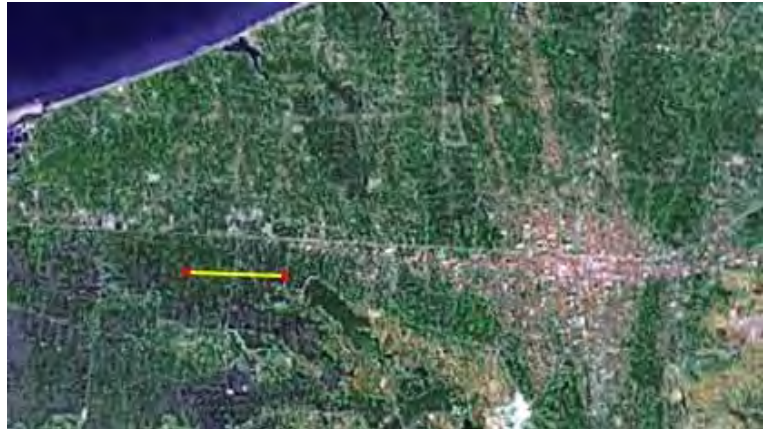
Figure 3.5 Dry Area Bireuen

However, the coordinates of the Dinas offices in Langsa and Lhoksuemawe were noted for future reference and the fact that there was a very dry area just west of Bireuen town was noted. This area obviously had rice planted but the fields were dry and the soils were cracking. Information from the respective Dinas office was that the irrigation system, covering a vast area, had been damaged by the earthquake and water supply was now not possible.

In the LandSat image the regularity of the irrigation canals can be seen as rectangular patterns.

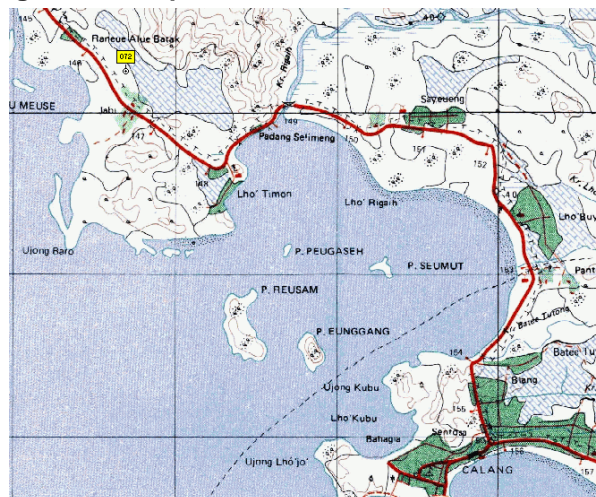
Figure 4.1 Proposed Dinas Site at Jabi

This site is shown as WP72 in the map below and is only a few hundred metres from the main road and about 500m from the ocean.

Previously: this site was a padi area with 2 crops per year possible. Palawija crops also grown with rubber and cloves being mentioned.

Damage: classified on the ISRI (Bogor 2005) maps as heavily damaged due to salinity level and depth of sediment.

However, since this area was presently totally covered in very vigorous, mixed vegetation and the surface showed a texture of fine sandy clay loam ETESP would not accept this as heavily damaged land.

Social: an active farmers group exists in the area and the leader of this is confident of full cooperation in any "cash for work" intervention.

Conclusions: this area has apparently recovered to a large extent and can now be fully recovered very easily using "cash for work" which would comprise:

- Clear the existing vegetation
- Re-establish the field plots
- Locate and clear all the drains to ensure they work efficiently, and
- Refurbish the irrigation supply

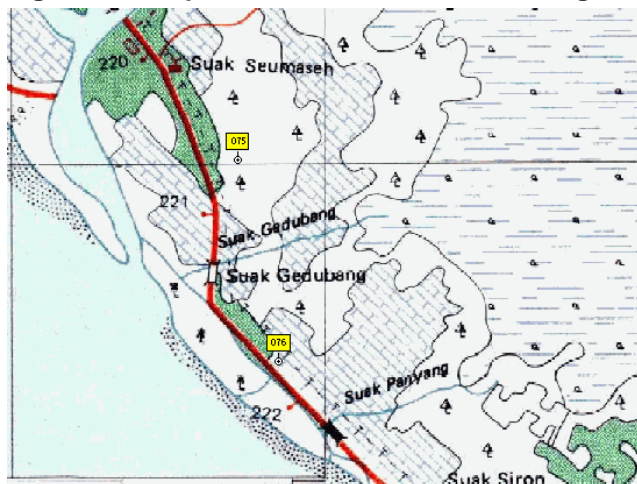
Figure 4.3 Proposed Sites at Suak Geudebang

- Site 1 – north of the village, site 75 in Figure 4.3, and covered in heavy vegetation, not flooded and 1km from the ocean. Site quoted as being 60 hectares in size
- Site 2 – south edge of the village, site 76 in Figure 4.3, with very large drains, high water-table, virtually at sea level and less than 500m from the ocean.

Site 1 (WP75): Previously: used for rain-fed padi with good yields being obtained

Damage: although badly flooded this site could only be described as lightly damaged in that there is now strong, mixed local vegetative growth and no flooding seems to presently exist. Topsoil texture could not be checked due to the density of vegetative cover but it seemed to be dark coloured and might possibly be peaty

Conclusions: this area would seemingly be relatively easy to clear and recover with the main problem being disposal of the excessive amount of local vegetation now covering the site. There would be too much to contemplate composting and burning would appear to be the only option

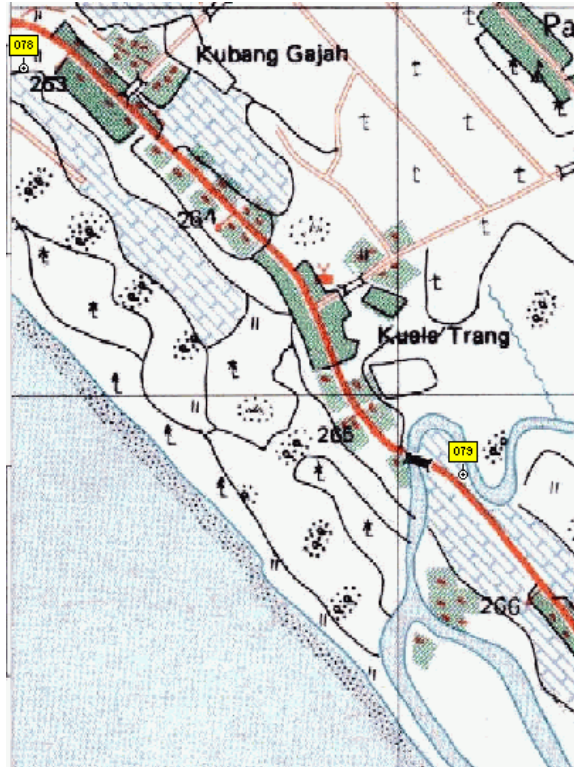
Figure 4.5 Proposed Dinas Site in Nagan Raya, Desa Kuala Trang

In Figure 4.5 waypoint number **78** is at Meulaboh airport whilst the site is number **WP79**.

Previously: this site was irrigated padi with good yields

Damage: this site was obviously heavily inundated as it lies at low level and is about 1km from the ocean – the flood would have had very easy passage up the river channel

Features: the site is very heavily vegetated, including some Phragmites sp that indicate that the site is very wet and flooded, there will be a huge problem in dealing with the cleared vegetation. Burning is probably the only solution

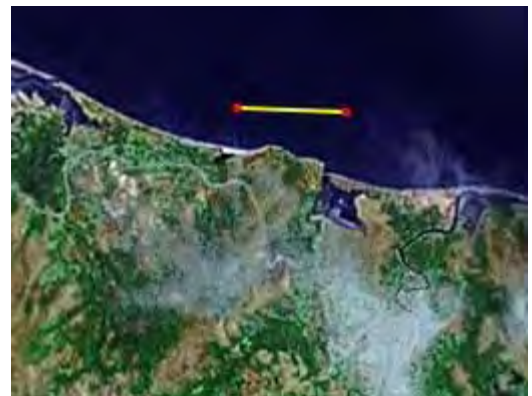
Figure 4.7 Leungah on LandSat

The promontory or headland at Ujung Bateeputeh may well have taken the brunt of the tsunami wave, the wave coming in from the North-West, and hence sheltering desa Leungah. This location might actually be considered as a totally new “scenario” for ETESP in that the site was only very slightly damaged with the inundation more like a “high”

tide. The local population continues to live in their original houses and there are no obvious signs of the tsunami having caused much in the way of physical damage.

Damage: as noted above there are no obvious signs of the normal, devastating damage inflicted on villages this close to the shore line; a possible explanation for this being suggested above below Figure 4.4. The flood was relatively gentle and about one metre deep and it did retreat very quickly. Damage would have been limited to salinity caused by the infiltration of the sea water.

Features: study of a village well revealed that the present water table is at about 3m depth and this well is situated at less than 20m from the shore line. The shoreline comprises dark coloured sand and this would have very high infiltration rate. It could be the case that the soils have high infiltration or hydraulic conductivity due to sandy layers and this might have led to relatively large amounts of sea water being infiltrated. Conversely, if such sandy layers exist, reclamation of the soils would have been easier and quicker due to the more rapid infiltration.

Conclusions: this area was very slightly damaged and through “self-help” the recovery or reclamation is well underway. It could be argued that this village does not need any or much assistance to fully recover. However, from a social point of view this village is relatively remote in Aceh Besar, there is a road but it is an unmade road, and more importantly the area has virtually been cut-off from the rest of the country for about 20 years due to the previous uprising. For social reasons and to help get some modernization into the farming system here “cash-for-work” could be of great value and allow the full repair of the irrigation and drainage systems.
