# Earthquake & Tsunami Emergency Support Project ETESP

# **Aceh Besar Kabupaten**

**Data Assessment and Soil Reclamation**

(December 2005)

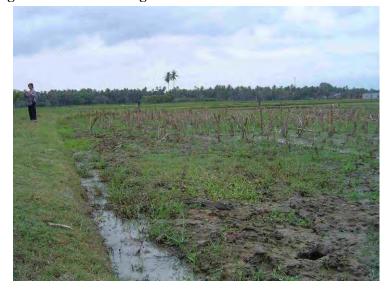
Figure 4.6 Poor Drainage at Site 17

The Suleue site can also be reclaimed and the task should be relatively straightforward here since the remnants of a drainage system still exists, but this needs to be rehabilitated. It is obvious, even in Figure 4.6 that the site is not draining and water is not leaving the field and getting into the drain on the left. Perhaps there is a plough pan that needs to be broken up to allow water to percolate.

However, in mid-December 2005 the corner area, near where the person is standing in Figure 4.6 was being used as a germination and production of rice seedlings and very minor drainage channels had been excavated. With some guidance the farmer could get the reclamation of this land underway.

Use of salt tolerant varieties could well give a crop after even the minimum of drainage and reclamation, but a more permanent solution would be to:
