EARTHQUAKE and TSUNAMI EMERGENCY SUPPORT PROJECT (ETESP) Executive Summary Soil and Land Reclamation

December 2005

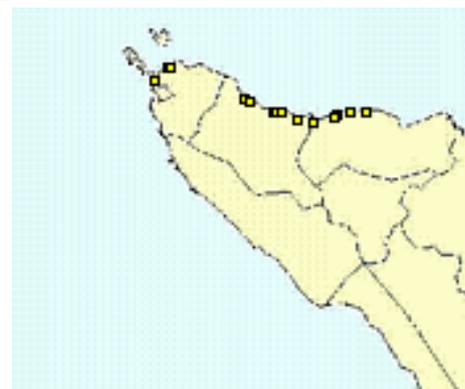
Figure 1 Location of Salinity Survey Sites

The spread of the sites along the north coast can be seen above, though the individual sites cannot be clearly seen. ETESP visited all of these sites to collect data on present salinity (December 05), water table depths, drainage status, crop or land condition and to collect GPS coordinates.

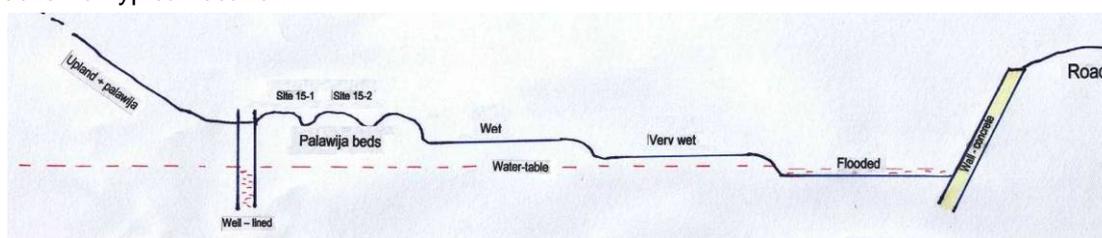
Cross Section of typical location

The soil is considered slightly to moderately damaged with salinity levels of 2-4dS/m (Salinity Class SC1) with reclamation normally being attempted by the farmer without guidance. But, the farmers are only having limited success and that is normally only on the highest parts of their farm. The main problem with such sites is a high water table and restricted drainage. Water tables at highest part of farm are at 50-75cm with salinity of 0.25-0.50dS/m (Class C2) and the water table is usually at the surface on the lower parts of the farm.

The water on and in the land just cannot escape from the site as there is no active drainage system and the natural stream lines have been blocked, often by man-made structures such as roads and concrete irrigation channels.

1. High water table which gets closer to the surface as the level of the land falls towards the natural stream lines
2. The land in the lower-slope positions is flooded since the water table is actually at the surface
3. Man-made structures, such as roads, urban and agricultural drainage ditches and irrigation channels, acting as dams and blocking the drainage
4. Inappropriate, surface flow irrigation methods are being utilised and these are perpetuating the salinity
5. No in-field or on-farm drainage and natural stream lines are no longer active

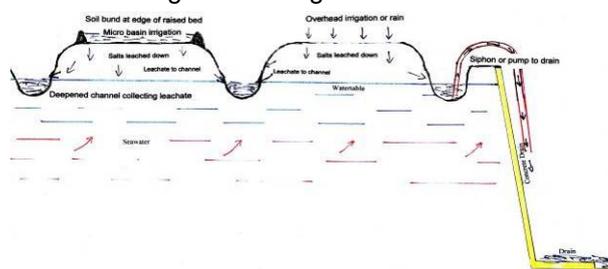
Overhead Irrigation Giving Desalinisation

A palawija cycle must be built into the cropping calendar to allow annual leaching and desalinisation

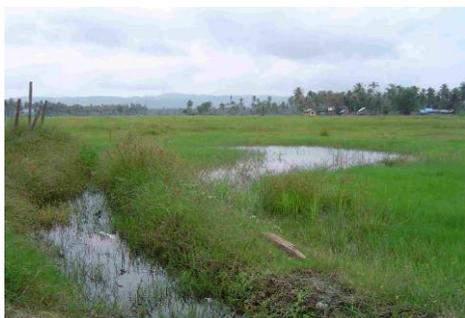
Typical site previously used for padi

Sites like this are on almost flat alluvial plains with no obvious high points, still totally or partially flooded, no cropping at all and covered in grasses which are being browsed by buffalo etc. and are close to the coast. But, at least one location, there was an operational drainage channel. Refer the photos below. However, local information was that this was, in fact, a previous irrigation system. The in-field water-flow in this channel was fairly fast and there was an outlet into a major channel which was obviously linked to the sea. This drain or channel was flowing - but very slowly. This drainage system was governed by tidal movement and the local estimate was that there is presently between 50-100cm of sludge, sediment and rubbish in the channel or drain.

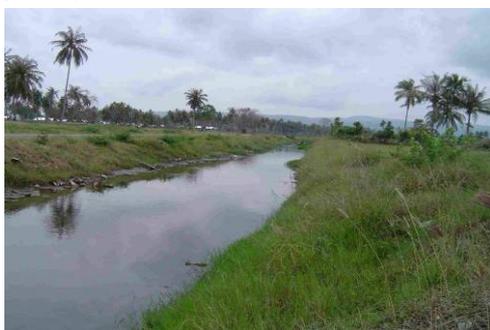
Existing badly silted-up channel

Deepen and clear all existing channels on, around and above the site, ensure all sediment and garbage is removed. Much of this can be done by the farmers under supervision and within the "cash-for-work" scheme.

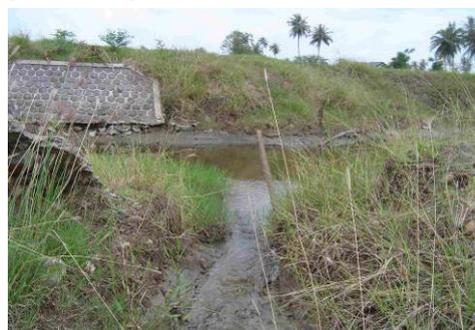
Drainage entering main channel

A follow up visit to the original site with this scenario showed water being rapidly drained from the site since drains had been cleared and / installed as necessary.

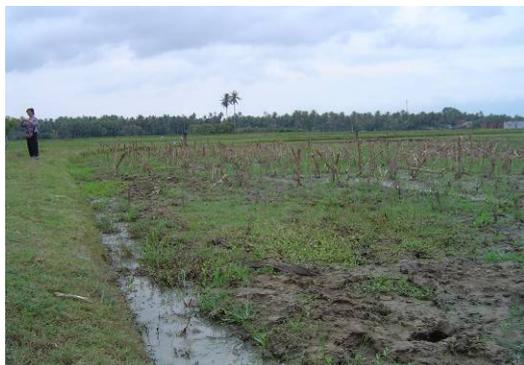
Raised bund above the soil drain

Level areas previously used for rain-fed rice but out-of-command of local irrigation systems and having the remnants of a soil drainage system. Soil salinity level about 4-6dS/m (SC2) and water table at 30-50cm with salinity level of 0.3-0.6ds/m (C2). Farmers have tried cropping but crops failed and sites now abandoned. Such sites can be quite badly damaged with the surface water virtually stagnant with algae etc growing and water is not passing into the existing drainage canal.

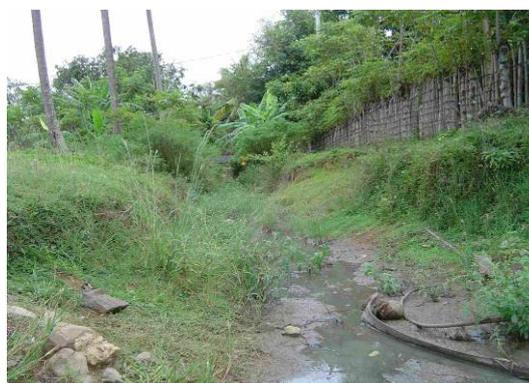
Badly damaged and blocked drain

Much of the damage to such drains is not due to tsunami effects but is due to long-term neglect and lack of maintenance of the drain.

Refurbishment will be mainly a civil engineering task and relatively expensive to implement but very necessary if not essential – not only for agriculture but also for social reasons.

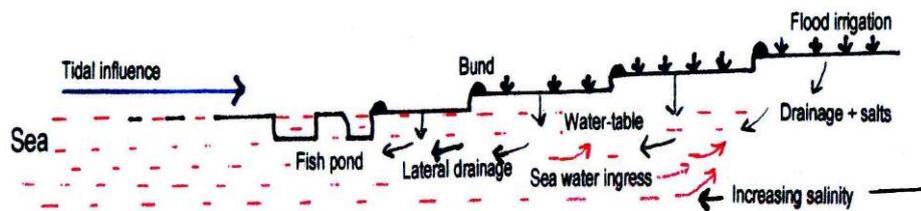
Salinisation of low lying site from the sea and irrigation

There is a progression of salinity increase down-slope with the soils at the top of the slope already back in production (Scenario 5) and the soils at the lowest points being badly flooded and very saline. There are at least two possible reasons for the salinity of these lower slope sites:

- Tidal influence and sea water ingress via the water-table, and
- Accumulation of salts in the lower slopes due to the sub-surface, lateral or sideways drainage of the soils further upslope. This is a natural phenomenon and is to be expected in any irrigation scheme, in particular where there has been inadequate provision of soil drainage

Salinisation is happening from the sea plus from the land and, for the worst affected areas, there is probably no way to reclaim the land and land-use should probably be changed to construction of fish ponds.

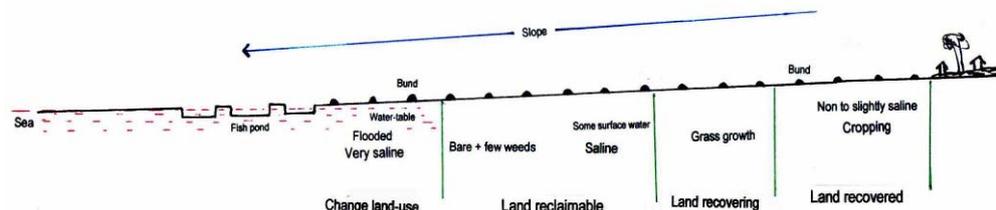
Cross section from village on high ground down-slope through padi area

The situation of this scenario is depicted on the right hand side of the diagram where the lower captions read "land recovered" and "Land recovering".

Land in this category no longer has a problem of any great significance, but there is an increase in salinity as one progresses down-slope away from the village on the high ground – this is because the first land to be leached would be the highest land and the saline leachate would have drained laterally down slope and added to the salinity of the lower slope sites. As long as there is sufficient rainfall plus continued application of irrigation water the land will continue to recover as the salts are leached out further and further down the slope.

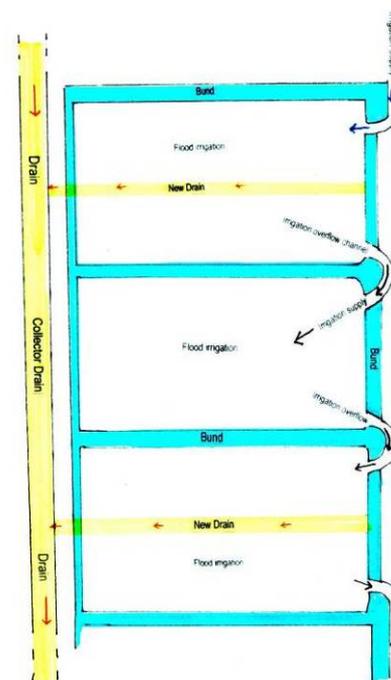
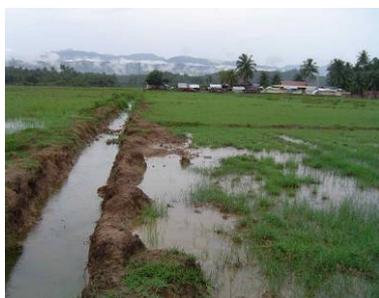
New field and existing collector drains

Additional drains should be installed on the contour; right across the width of the padi fields and disgorge into the existing collector drain. The field drains should be deep enough to ensure that the bottom of the drain is below the maximum rooting depth of the crop (rice) being grown and, generally should be somewhere between 60 – 75cm deep, whilst the existing collector drains are already about 100cm deep.
