### ETESP Soil and Land Reclamation Scenarios

Update of March 2006

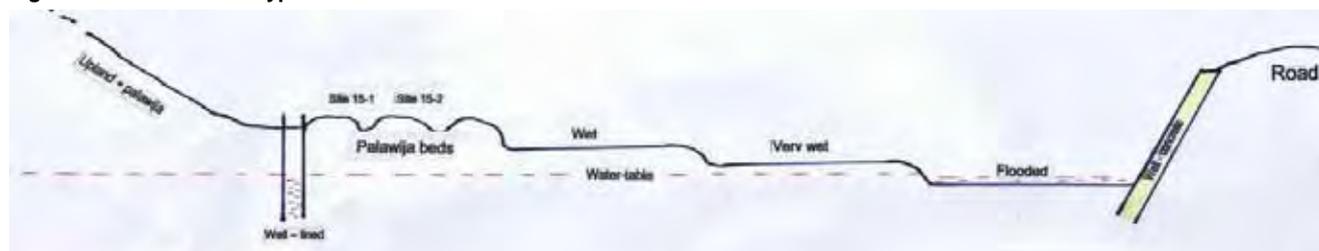
Fig 1.1 Cross Section of typical location

The water on and in the land just cannot escape from the site as there is no active drainage system and the natural stream lines have been blocked, often by man-made structures such as roads and concrete irrigation channels.

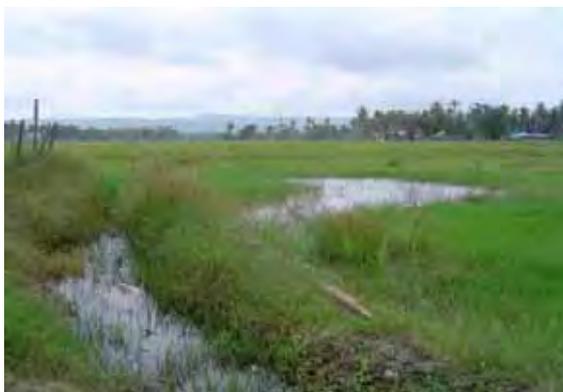
**Fig 2.1 Typical site previously used for padi**

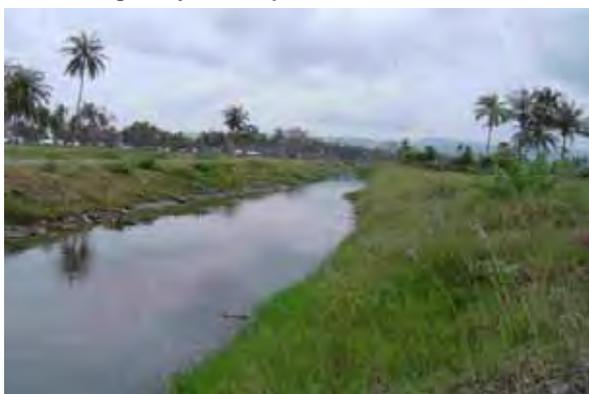
Sites like this are on almost flat alluvial plains with no obvious high points, still totally or partially flooded, no cropping at all and covered in grasses which are being browsed by buffalo etc and are close to the coast. But, at least one location, there was an operational drainage channel. Refer the photos below. However, local information was that this was, in fact, a previous irrigation system. The in-field water-flow in this channel was fairly fast and there was an outlet into a major channel which was obviously linked to the sea. This drain or channel was flowing - but very slowly. This drainage system was governed by tidal movement and the local estimate was that there is presently between 50-100cm of sludge, sediment and rubbish in the channel or drain.

**Fig 2.2 Existing badly silted-up channel**

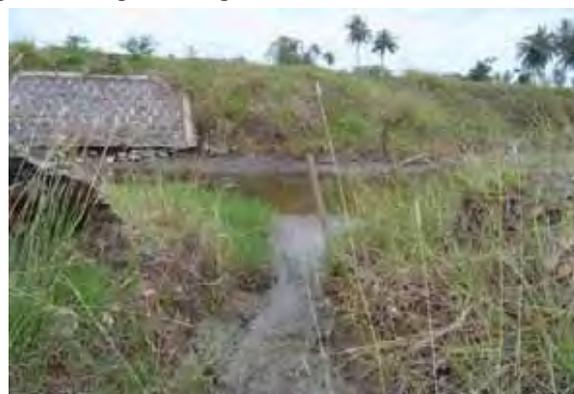
**Fig 2.3 Drainage entering main channel**

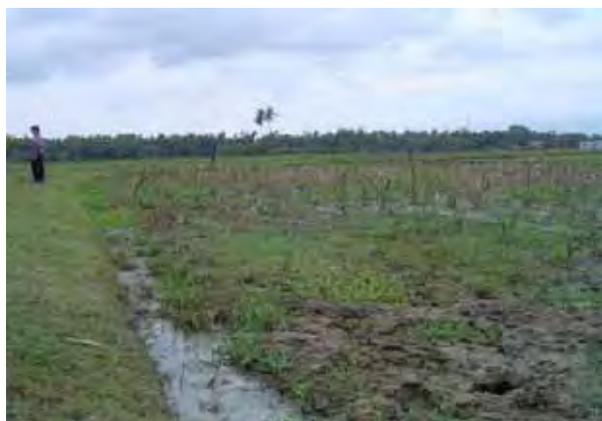
**Description:** Level areas previously used for rain-fed rice but out-of-command of local irrigation systems and having the remnants of a soil drainage system. Soil salinity level about 4-6dS/m (SC2) and water table at 30-50cm with salinity level of 0.3-0.6ds/m (C2). Farmers have tried cropping but crops failed and sites now abandoned. Such sites can be quite badly damaged with the surface water virtually stagnant with algae etc growing and water is not passing into the existing drainage canal.

**Fig 3.1 Raised bund above the soil drain**

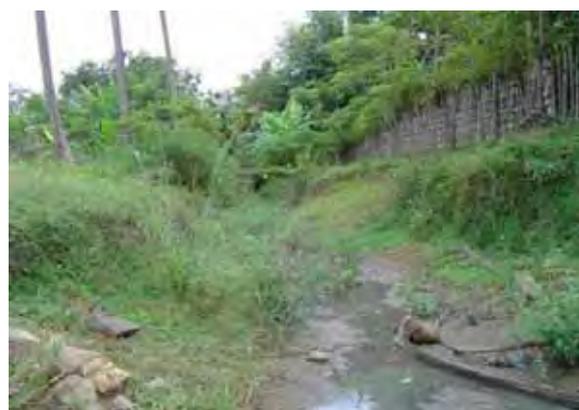
- Much of the damage to such drains is not due to tsunami effects but is due to long-term neglect and lack of maintenance

**Fig 3.2 Badly damaged and blocked drain**

Refurbishment will be mainly a civil engineering task and relatively expensive to implement but very necessary if not essential – not only for agriculture but also for social reasons.

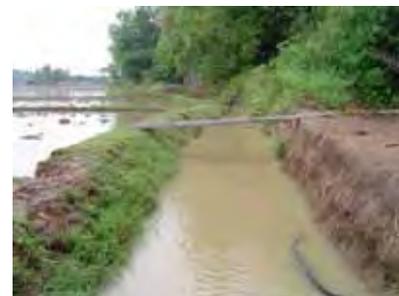
Fig 4.2 Collector Drain

However, there is often a larger drainage channel running directly down-slope at the opposite side of the field from the inlet for the irrigation water, hence there is some drainage of the land.

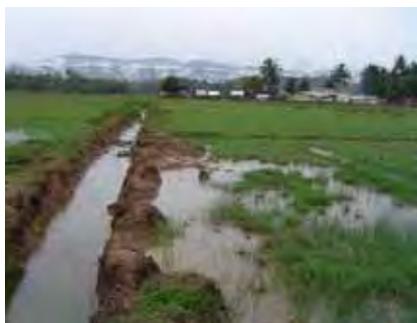
**Fig 5.3 Field Drain**

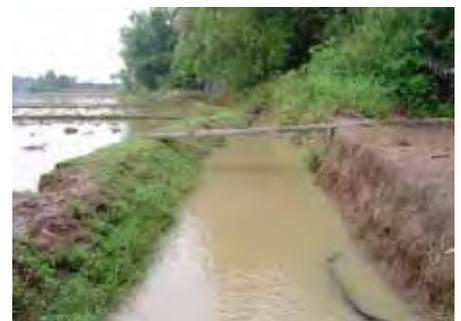
**Fig 5.4 Drainage Ditch / Collector Drain**

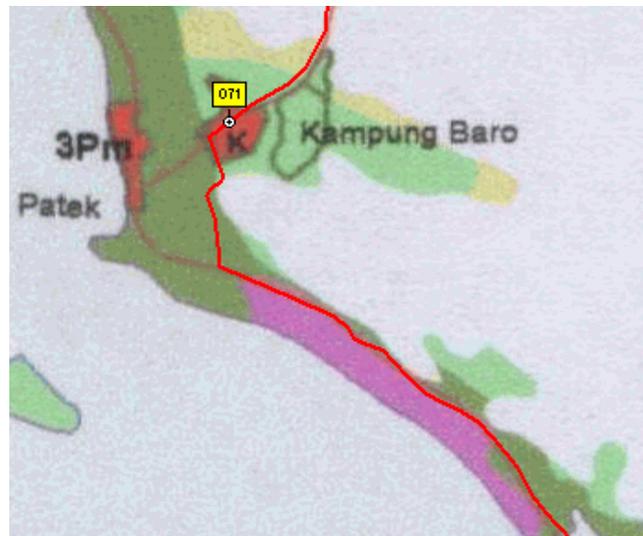
Fig 7.2 Scenario 7 and ISRA Mapping

**NB** The above Figures are not produced to be the same scale but are not vastly different in scale. The grid on the left hand map is at the 1:50,000 scale

Study of the ISRI mapping in that area, enhanced with the road (GPS track) alignment, indicates that the scenario in question lies more or less on the boundary between the purple and dark green areas on the ISRI map. The purple area represents moderately to heavily salinised land, with and without significant sediment additions, and generally with coarse textures whilst the dark green represent medium textured soils which are classified as moderately damaged due to medium levels of salinity and sediment coverage.

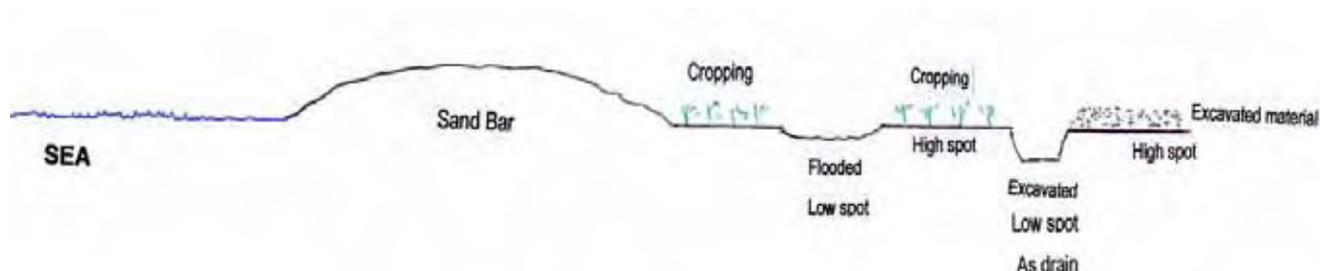
Fig 7.3 Cross Section of Scenario with Proposed Intervention

Study of the contours on the topographic map show that the coastal strip in this area is quite narrow and any land that can be reclaimed could possible be of value if there are sufficient local people still in the area trying to re-commence farming. A graphic representation of the existing cross-section with an indication of the intervention is shown below.

**Recommendation:** Immediate implementation of this intervention could be done by the farmer with some technical guidance and he could excavate material from the low spot(s) adjacent to his cultivated area and start to build up a deeper soil bed on the high spot. Some time would have to be allowed for the salinity in the excavated material to leach out through the effects of rainfall. However, to carry out more extensive excavation and link the low spots converting them to drains would require assistance in the form of civil engineering advice and use of heavy equipment.

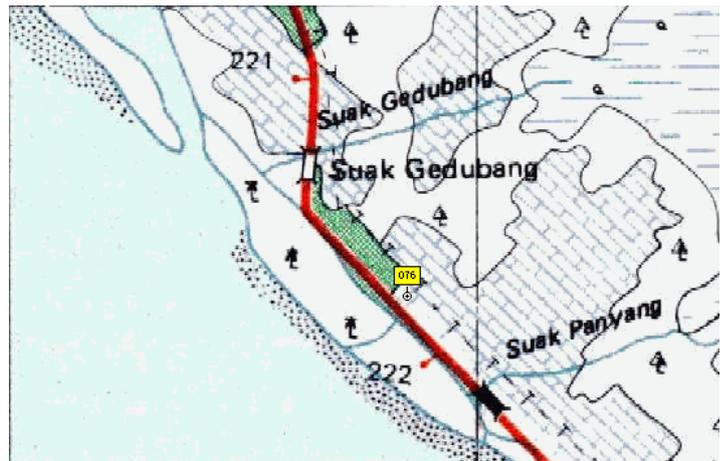
Fig 8.1 Extract of Topographic Map around Suak Geudebang

- As can be determined from the map this site is only 500metres from the coast, virtually at sea level and is 1.5km from a large swamp area which lies to the north east
- The channels were full to the top with water but the quality of that water was not tested – neither salinity nor reaction (pH)
- Soil depth above the water level was about 20cm, again the type and status if that soil was not tested since the channel could not be crossed

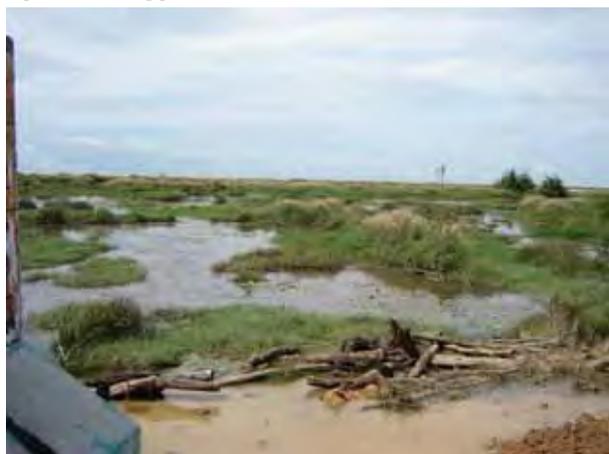
**Figure 6.1 Clogged river**

**The Problems:** The effect of this debris and sand-bars is that the river flow is vastly reduced or stopped all together; often the river is considerably wider than it was and very often flooding the land through which it flows. The knock-on effects are that the river is no longer able to transport water from upstream – and this water will contain the saline leachate from the sites that are being reclaimed – and remove the dissolved salts from the land by transporting them back to the sea. The large lagoons or ponds being formed by this river flooding will slowly be increasing in salinity.

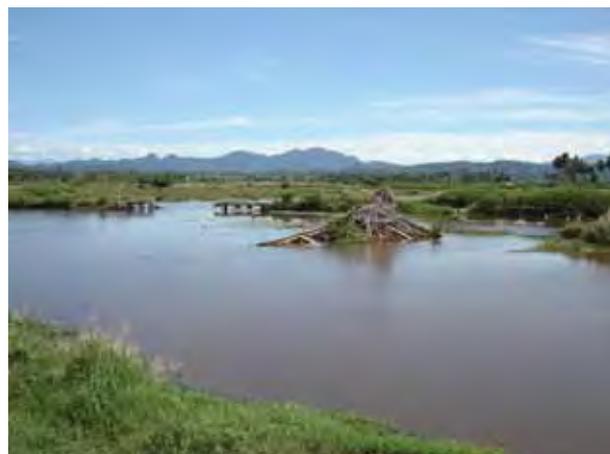
**Figure 6.2 River Flooding**

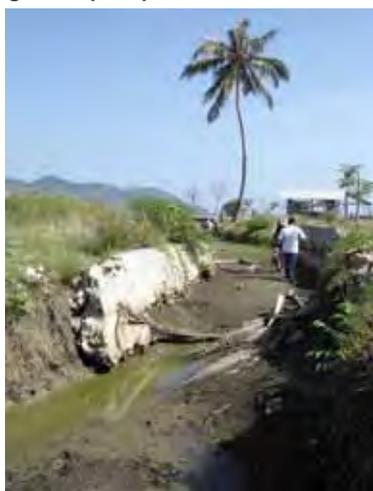
The situation can be seen in Figures 10.2 and 10.3. In Figure 10.2 there is slope upwards to the road, which runs below the coconut palm, whilst Figure 10.3 is the view from the bridge over the canal at the road down-slope towards the ocean. In this case the 'high-point' or water-shed appears to be the road line. The road can be seen in Figure 10.4.

**Fig 10.2 Up-slope to the road & sea**

The drain shown in Figures 10.2 And 3 runs northwards from the yellow box (5) on the possible flow line, through the "a" of Lambade and the yellow box (6) directly northwards towards the sea. The small ridge, represented by the contour line, seen entering the area just below the road in the lower left corner, continues eastwards towards Langurun and lies at about 15masl. The stream line is not marked on the map but the red line has been drawn in the approximate valley bottom position.

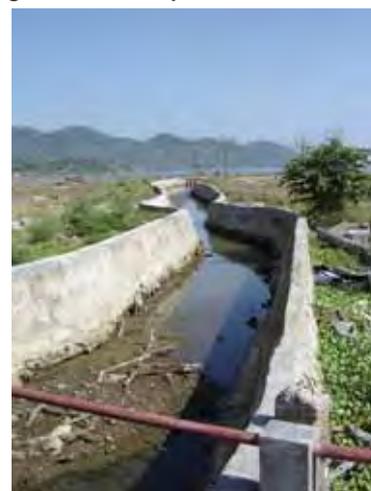
**Fig 10.3 Down-slope from road to sea**

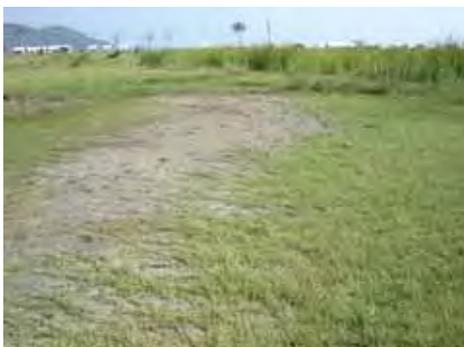
**Fig 11.1 Sandy Sediment on Soil Surface**

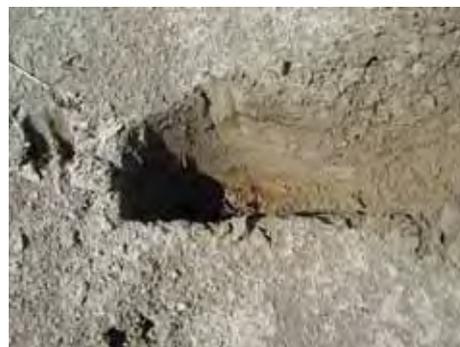
**Fig 11.2 Grayish Coloured Sands Over Brownish Original Soil**
