Earthquake & Tsunami Emergency Support Project

Banda Aceh Kota

BPTP Demonstration Plots

Data Assessment and Soil Reclamation

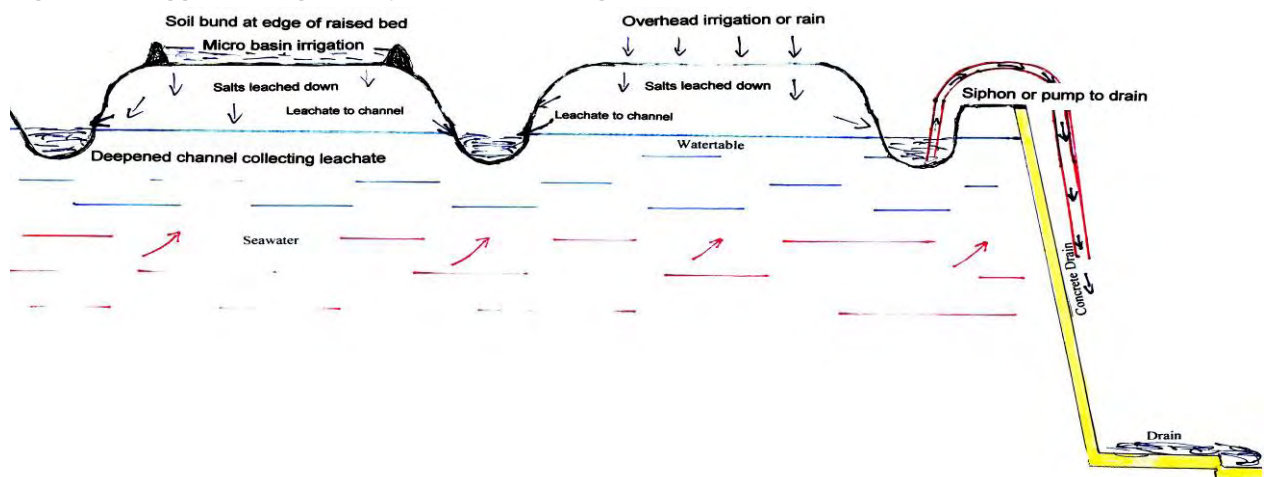
Figure S.3 Suggested Irrigation System with Drainage

However, it must be emphasized that the ground water-table is too high and any salts being leached from the soil are going into the groundwater then being re-applied to the soil in the irrigation water. The leachate must be removed from the site in a drainage system.

To carry out reclamation to achieve close to pre-tsunami salinities would require that 52mm of water passes down through the profile to a depth of 50 cm and be removed from the site as drainage water.

This reclamation procedure could be completed with just 2 - 3 irrigations of 100mm of irrigation each, probably applied about one week apart, but after a drainage system is installed. That is to have 52mm pass down through the profile about 300mm need to be applied to the surface.

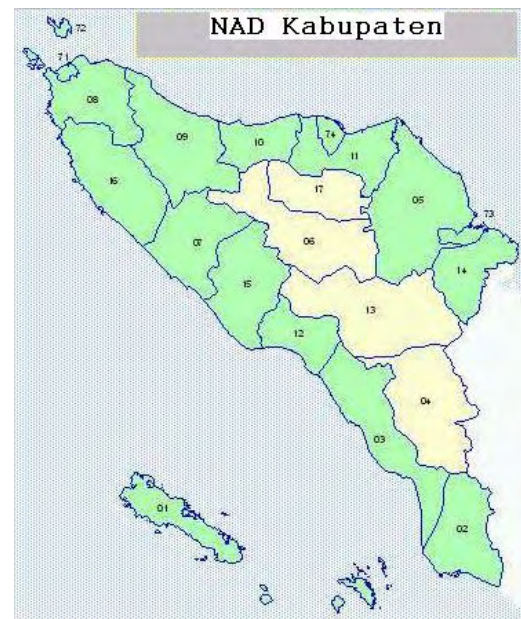
Figure 1.1 NAD Kabupaten

The Desalinisation and Soil Improvement Specialist was tasked with assessing the situation and designing remedial interventions to enable the reclamation of the soil and farmland to enable agriculture to resume as quickly as possible. All the Kabupaten within the immediate study area are shown in Figure 1.1 and Banda Aceh is labeled 71 at the very top of the island of Sumatra and it is a site from this area that is reported here.

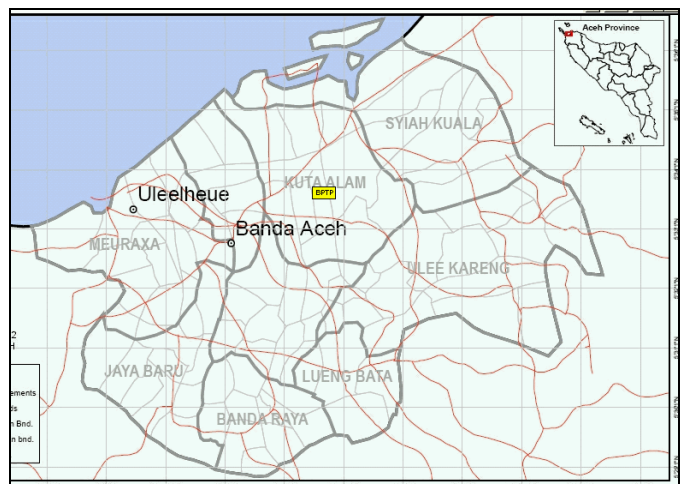
Figure 1.2 Kota Banda Aceh and BPTP Plots

Figure 1.2 shows that Kuta Alam shares an exposed section of the coastline with Meuraksa, Kut Raja (not named on the map though the boundary can clearly be seen) and Syiah Kuala. Accordingly the situation as reported for Kut Alam is most likely to be very similar in these other two areas for similar locations and land-use.

Within the Banda Aceh Kabupaten the only location for which tsunami related soil data have been located was the site of the BPTP office in Kuta Alam and the location of that site can be seen in Figure 1.2. The original data did not include GPS coordinates and the site has been located on the map below from recently taken coordinates and downloaded to the map which was extracted from the ADB map collection and geo-registered in the GPS software Ozi Explorer. Measurements from the on screen digital map put the site at just on 4km from the sea.

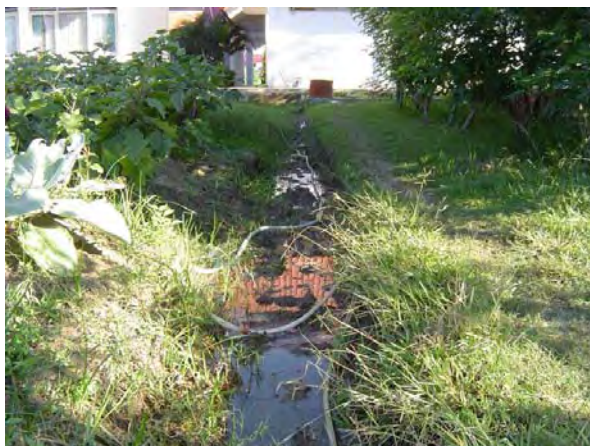
Figure 2.1 Irrigation Channel and Water-table

The water table throughout the BPTP compound is very high and in late October 2005 was at 32cm below the ground surface. The figure of 32cm was measured at where there was free standing water in any channels within the agricultural area and in several wells scattered over the site.

The crops were being grown on raised beds of approximately 18cm above natural ground level – this means that, at maximum, there was a soil depth of only 50cm (32 + 18) for the crop rooting system to exploit.

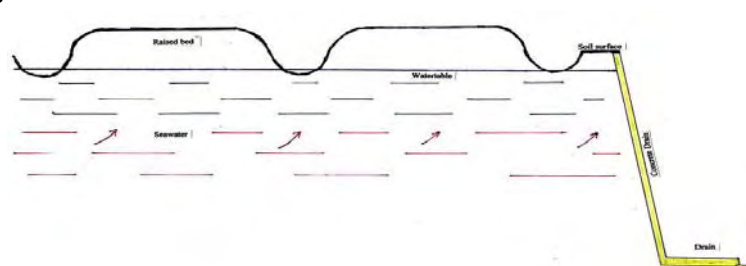
Figure 2.2 Water Table

To improve the soil and get better outputs the water table has to be lowered. It should be noted that the situation is actually made worse by the drain running along the main road outside the office complex. Also, there is suspected sea-water ingress from below continually recharging the water table.

The concrete wall of the roadside drain acts as a sub-surface dam and prevents natural, lateral flow drainage.

Any drainage pipes originally linking the soil to the drain have obviously been blocked for a long time as no evidence could be seen of any flow into the drain from the plots.

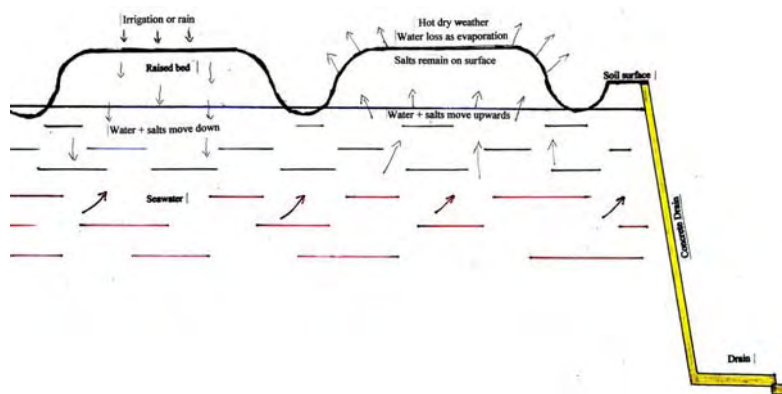
Figure 2.4 Effect of Rain or Overhead Irrigation

Similarly, if irrigation water is applied as an overhead irrigation (sprinkler or spray), or if it rains, the water dissolves the salts on the surface and, at first, the water will move downwards in the soil profile – but when it meets the water-table the downward movement ceases and the salty water stays near the top of the water-table. If evaporation then occurs, as it does when the soil dries out, the salts return to the surface of the soil. These situations are depicted in Figure 2.2.

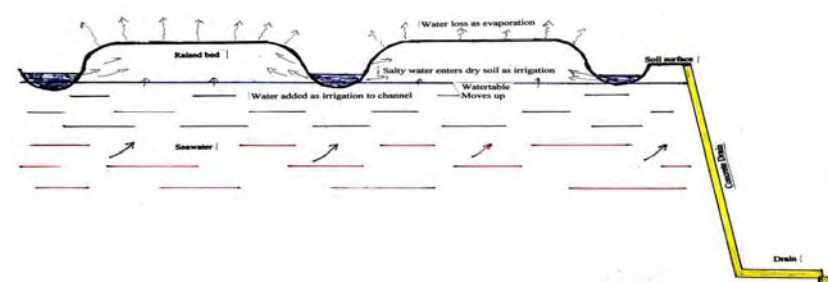
Figure 2.5 Effect of Surface Irrigation

If irrigation water is applied as a surface flow system, as is currently done at the BPTP site, the water enters the furrow or channel and creeps into the dry soil above it through “capillary” rise – this is a natural phenomenon that happens in soils. The water then does become available to the roots of the plants in the raised beds – however, the water “creeping” into the soil will dissolve any salts it encounters and move them upwards in the soil profile. This is happening and this form of husbandry is adding to the salinity problem and there is no way that full reclamation can work using this system of irrigation.

If, however, the water-table could be reduced (lowered) and the crop left to survive on rainwater alone, or overhead application, the salinity level could reduce and the situation normalized.

In such situations, where normal drainage is just not possible, some beds can be sacrificed for use as “dry drainage”. The principle is that if an area is left un-irrigated, and possibly protected from precipitation, groundwater will migrate to the dry area through sub-surface “lateral flow” and take the salts with it. When the water evaporates the salts are left behind and the water table will have been reduced to some extent and some salts will have been taken out of circulation.

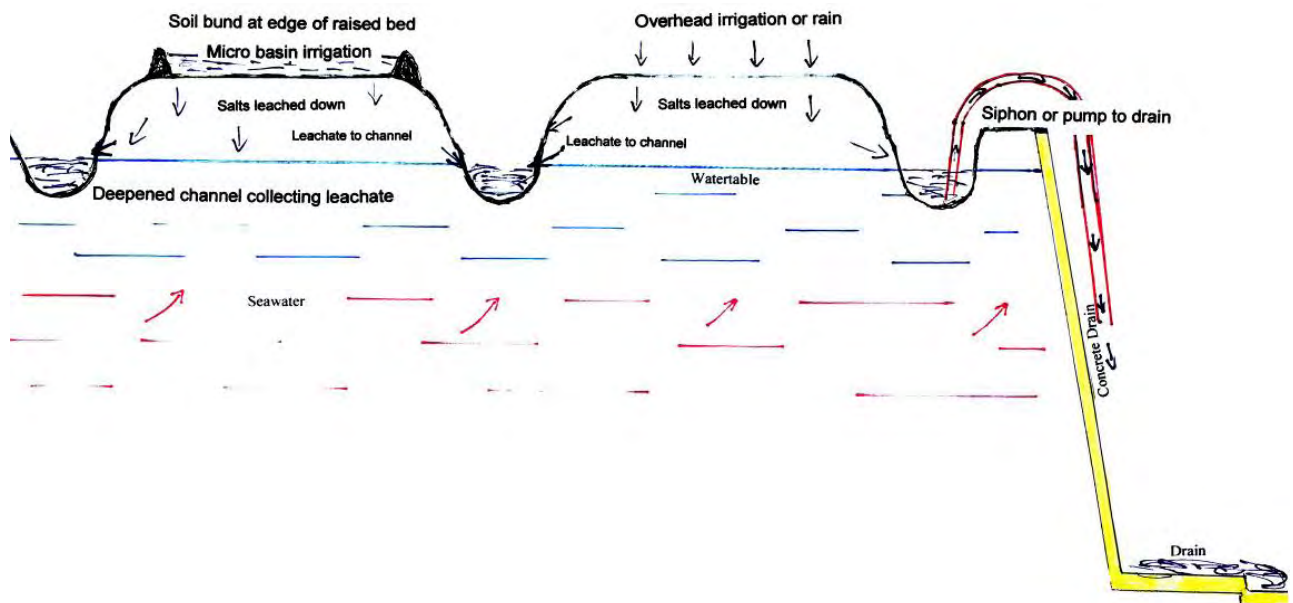
Figure 3.1 Outline of Suggested System

1. Sprinkler / spray or drop irrigation: The simplest forms of this would be
 - Utilisation of hand held watering cans, or
 - Use of a raised pipe system with the outlet a simple shower head
2. Small basin flood irrigation
 - Once the beds have been raised by adding more soil redesign them so that basins can be constructed on top of each bed – the edges would be as used by farmers and be constructed of soil, which would grass over in time, and protect them from erosion. The mini bunds would only need to be 10 – 15cm high, just enough to hold a normal depth of irrigation water.

If the above were done it would ensure continual leaching of salts from the soil and even allow the use of the groundwater to continue as the main source of irrigation water since there is a relatively large “bonus” of rainfall to give regular leaching with “purer” less saline water.

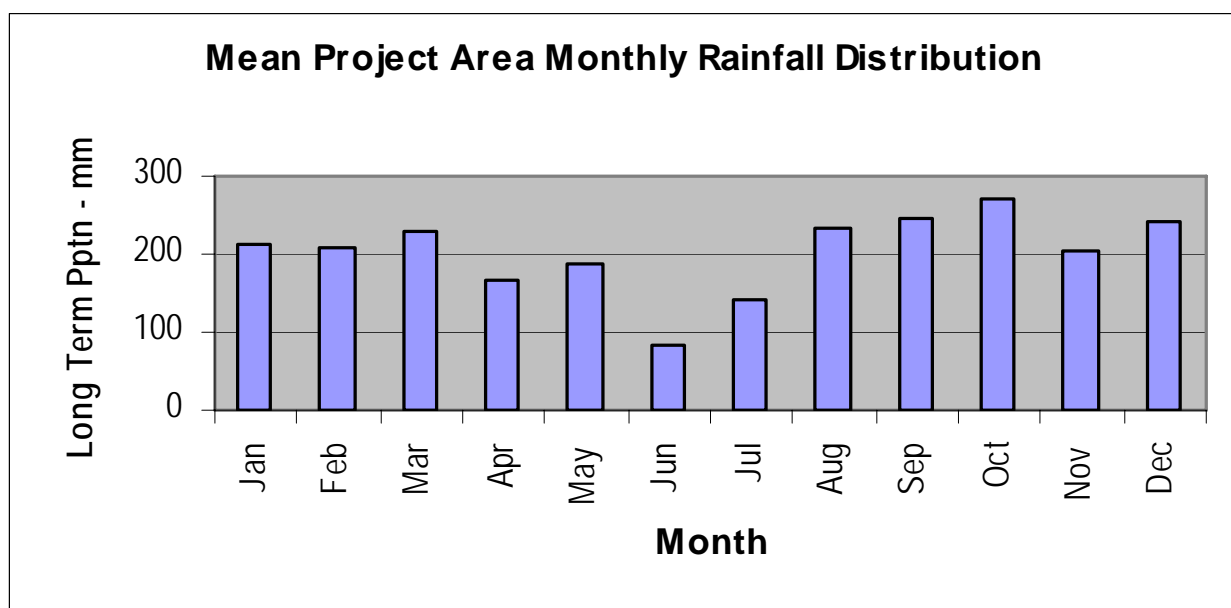
Figure 1 Rainfall Distribution – monthly, average for project area

The full spreadsheet showing the percentages per month etc is shown as Appendix 1 and rainfall distributions graphs (block diagrams) are shown in Appendix B. The overall rainfall distribution for the project area, for which data are held, is shown in Figure 1.

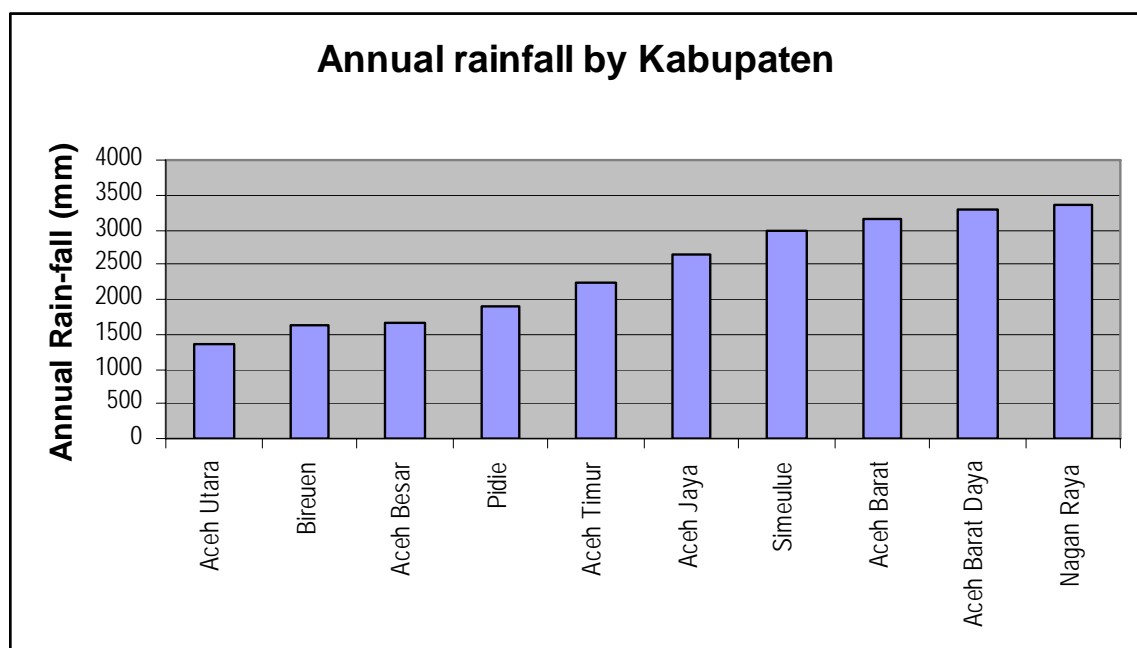
Figure 2 Long Term Precipitation by District (Kabupaten)

- The lowest rainfall, less than 1500mm, in Aceh Utara which is at the eastern end of the N coast
- Average of around 1700mm found along the N coast
- Average of around 2400mm in the band with Aceh Jaya in the W and Aceh Timur in the E and at about the same latitude
- The lower west coast, including the island of Simeulue, having the highest – overall average of over 3200mm

It appears that rainfall decreases as one comes north and the pattern appear to be governed by latitude (how far north) and not location on the north or west coast. What has, in most previous reports, been referred to as the east coast is, in fact, largely a north coast! Only Aceh Timur should really be considered as lying on the east coast.
