EARTHQUAKE and TSUNAMI EMERGENCY SUPPORT PROJECT (ETESP)

IRRIGATION SITES – LHAMNO, ACEH JAYA

(March 2006)

VISIT TO ETESP IRRIGATION SITES, LHAMNO, KECAMATAN JAYA, ACEH JAYA

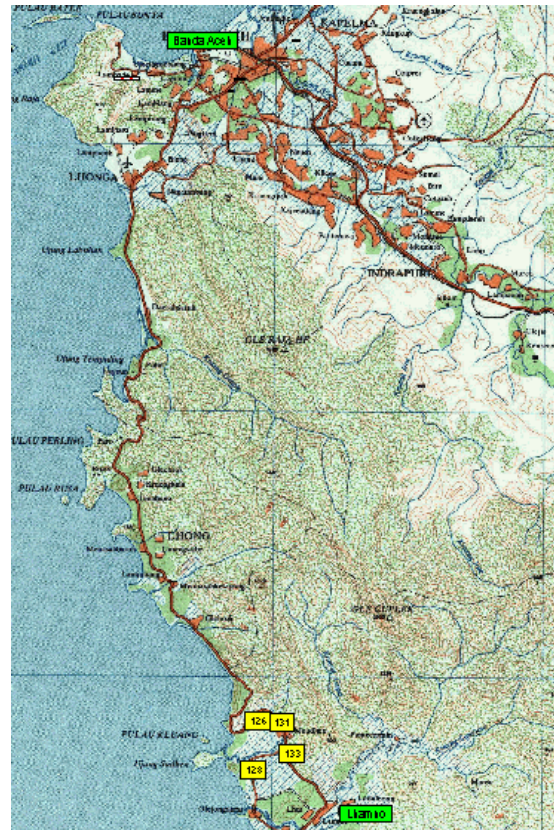
Figure 1.1 Location of Sites

The sites in question lie about one to one and a half hours south of Banda Aceh by road and can be seen in Figure 1.1. The yellow “waypoint” markers indicate the upslope edge of the irrigated areas where the irrigation canals first discharge.

The map in Figure 1.1 is extracted from the digital copy of the Bakosurtanal topographic series at a scale of 1:250,000. Other maps are:

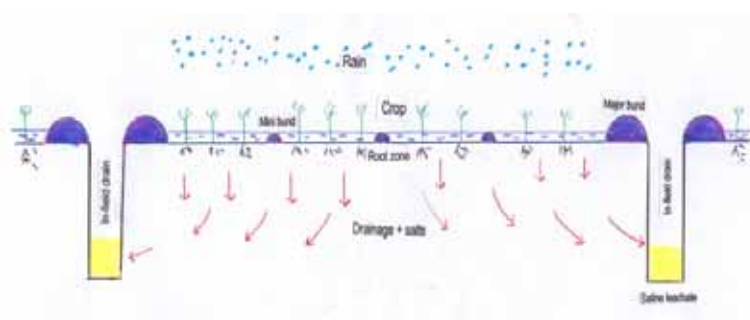
Figure 3.4 In-field Drains Cross Section

In-field drains are drains that are dug at intervals in a network that covers all of the irrigated or cultivated area. More detail on the subject can be found in ETESP “Scenarios” – Scenario No 6, Update of March 2006.

There was no obvious existing in-field drainage system seen on these sites.

On these locations drains have not been seen and these should be constructed to obtain maximum efficiency of the installation. As suggested in ETESP report “Soil Conditions for Wetland Rice” in-field drains should be excavated to 100cm depth to allow full desalinisation and reclamation of the entire root zone for rice.

In-field drains have to have bunds installed along their length to prevent surface water (rainfall or irrigation) from flowing directly into the drain instead of infiltrating into the soil.
