Earthquake & Tsunami Emergency Support Project

ETESP

Bireuen Kabupaten

Data Assessment & Soil Reclamation
(December 2005)
(With map updates of April 2006)

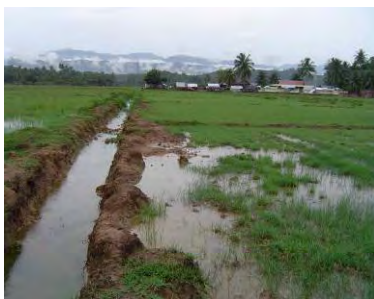
Field Drain

With the installation of drains there will be an immediate increase in the amount of water, some of it possibly saline, draining off these upper slope sites and trying to find its way down-slope to the sea. All channels downstream and the outlet to the sea must be unrestricted or increased flooding at the shoreline will happen.

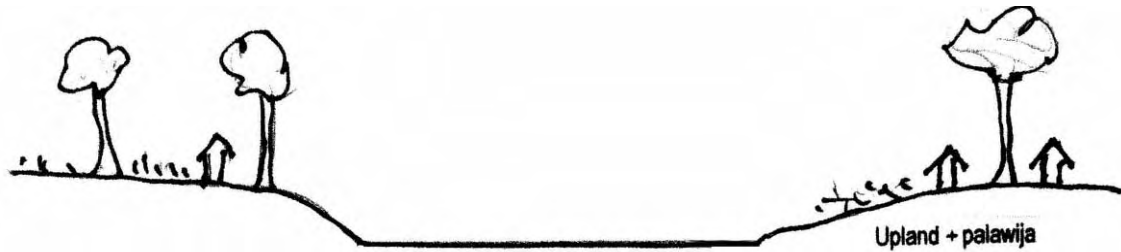
Figure 6.3 Idealised Cross Section for Site 11

this site. There was, however, no drainage visible for this site. The site was 100% flooded with rain water (EC 0.67mS/m) and there was no crop in the ground. Normal farming pre-tsunami gave 1 – 2 crops of rain fed padi.

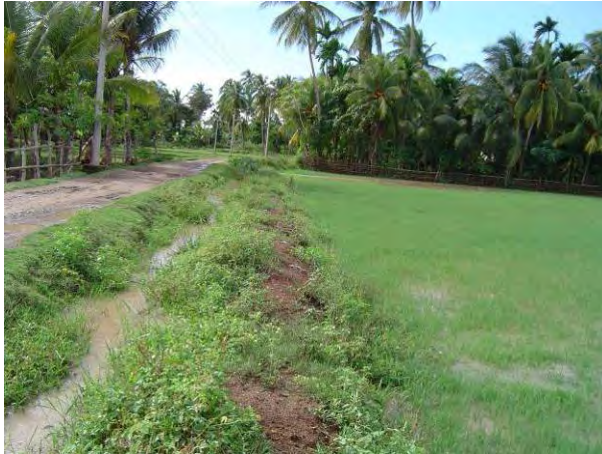
Figure 6.5 Irrigation Supply at Top of 11-2

Site 11-2 lies right at the top of the slope in an almost flat alluvial plain, located between islands of upland, and has the irrigation supply for this block of land as the upper boundary. The irrigation supply had water with EC of 0.01ms/cm. There was a drainage system but the first drains were, reportedly, quite far away down slope from the actual site. The farmer advised that pre-tsunami he could grow 2 – 3 crops of padi per year. There was no crop currently in the ground but the farmer stated that since the grass, growing on the site, was very even and very green he felt that it was now safe to plant his crops. Site 11-2 lies on the right hand side just below the dry land in Figure 4.3 in the area labeled ‘land recovered’ and as seen in Figure 6.6.
