EARTHQUAKE and TSUNAMI EMERGENCY SUPPORT PROJECT (ETESP)

OXFAM SITES SOUTH OF CALANG

(March 2006)

VISIT TO OXFAM SITES SOUTH OF CALANG

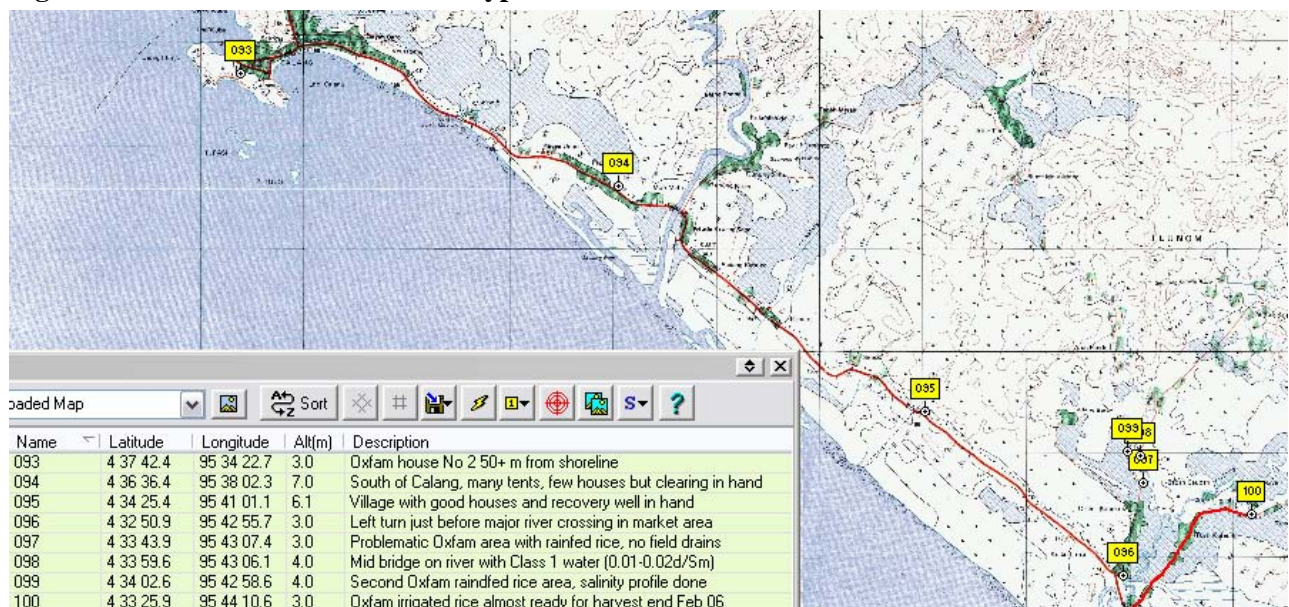
Figure 2.1 Locational Details with Waypoint Data

Oxfam operate out of Calang in Aceh Jaya Kabupaten and the sites in question are in Kecamatan Panga. In Figure 2.1 the yellow boxes are the numbers of Waypoints (WPs) collected by GPS during the trip. Details of what was noted at each waypoint can also be seen in Figure 2.1 but these details - apart from the sites at WPs 97, 99 and 100 - are not discussed in this report but are presented as a matter of course since the data were collected.

The sites are all located approximately 30 minutes south of Calang on the northern side of the main road at a distance of 3 - 4 kilometres from the coast at an altitude (GPS derived) of between 3 and 4 metres above sea level.

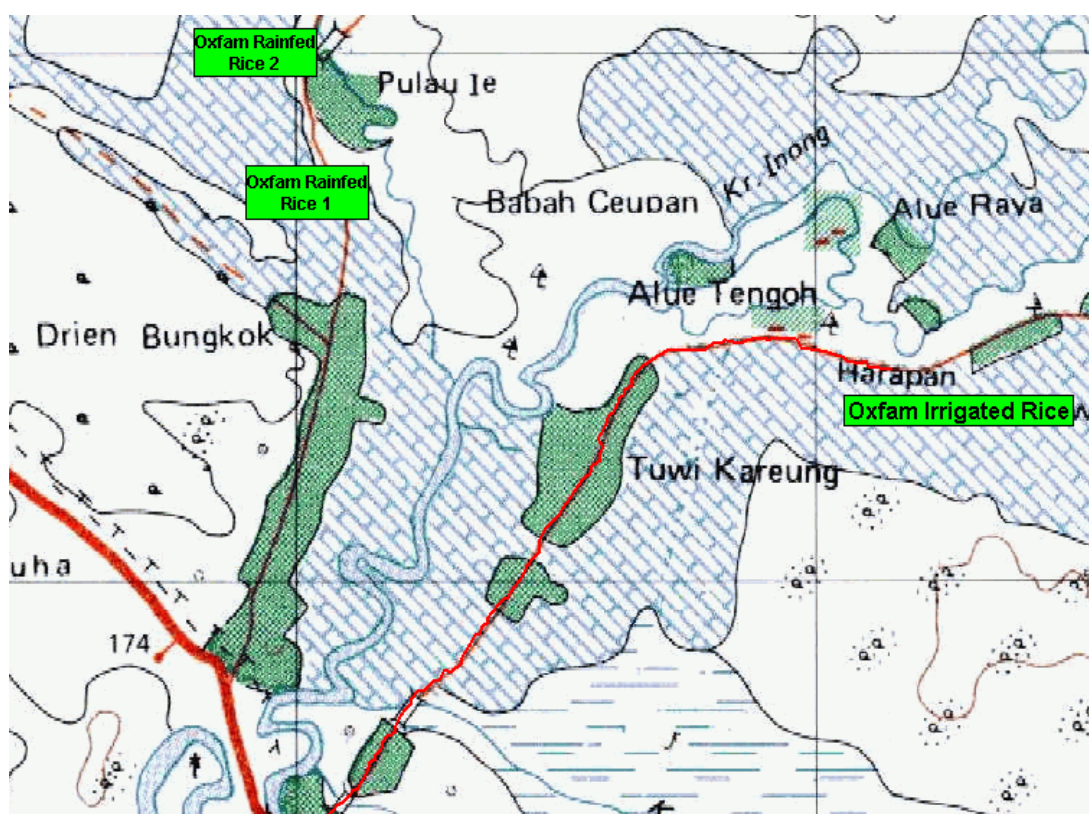
Figure 4.1 Extract of 1:50,000 Scale Topographic Map with Oxfam Sites

Site / WP No	ETESP Legend *	Present Land Use and status	Findings	Requirements
97	Oxfam rain fed rice 1 4km from coast	Rice at the vegetative state with surface flooding	Rain fed rice in the early or vegetative stage is growing quite vigorously but rice in such fields has often totally failed to develop any grain	This land requires field drains and, if irrigation were contemplated, land leveling to help achieve full recovery
99	Oxfam rain fed rice 2 4.5km from coast	Rice at the vegetative state with surface flooding	As above but with some minor channels (possibly erosional in origin) which are draining some sections	This land requires field drains and, if irrigation were contemplated, land leveling to help achieve full recovery
100	Oxfam irrigated rice 4km from coast	Irrigated rice with grain and almost ready to be harvested	This land would appear to have been reclaimed and is back in production but, no prediction of expected yield is made here.	This land appears to have recovered but some fertiliser inputs may be indicated once the yield obtained is measured
