Earthquake & Tsunami Emergency Support Project

ETESP

Pidie Kabupaten

Data Assessment & Soil Reclamation
(December 2005)
[maps updated April 2006]

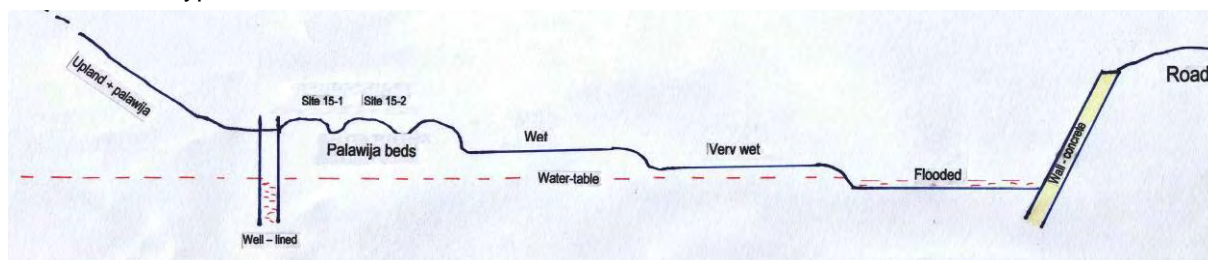
Cross Section of typical location

The soil is considered slightly to moderately damaged with salinity levels of 2-4dS/m (Salinity Class SC1) with reclamation normally being attempted by the farmer without guidance. But, the farmers are only having limited success and that is normally only on the highest parts of their farm. The main problem with such sites is a high water table and restricted drainage. Water tables at highest part of farm are at 50-75cm with salinity of 0.25-0.50dS/m (Class C2) and the water table is usually at the surface on the lower parts of the farm.

The water on and in the land just cannot escape from the site as there is no active drainage system and the natural stream lines have been blocked, often by man-made structures such as roads and concrete irrigation channels.

1. High water table which gets closer to the surface as the level of the land falls towards the natural stream lines
2. The land in the lower-slope positions is flooded since the water table is actually at the surface
3. Man-made structures, such as roads, urban and agricultural drainage ditches and irrigation channels, acting as dams and blocking the drainage
4. Inappropriate, surface flow irrigation methods are being utilised and these are perpetuating the salinity
5. No in-field or on-farm drainage and natural stream lines are no longer active

1. Install in-field & on-farm drainage, these can be farmer-installed with guidance and instruction
2. Clear, unblock and restore natural drainage lines and ensure they connect to the local river or drain
3. Deepen in-field furrows so they can act as drains to remove any saline leachate produced – the farmer can implement this
4. Apply irrigation as overhead and not surface-flow, this will better enable soil leaching – use watering cans or appropriate, low-cost technology with piped or pumped supply
5. Use salt tolerant varieties and, for the immediate future, only grow palawija on raised beds with overhead irrigation techniques.

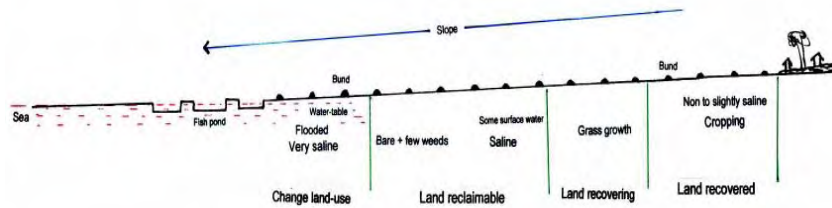
Cross section from village on high ground to fish ponds and the sea

This scenario is found mainly in the Pidie and Bireuen areas and is associated with the lower slope positions of irrigation schemes, near the coast and where fish ponds already exist.

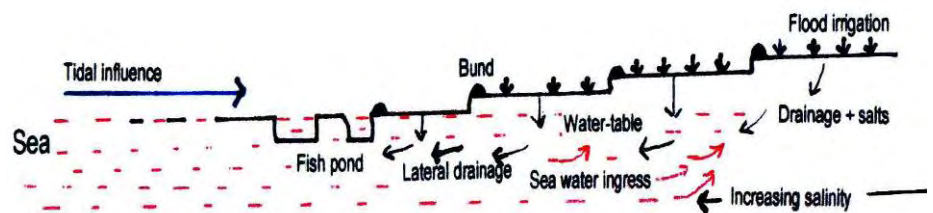
Salinisation of low lying site from the sea and irrigation

- Tidal influence and sea water ingress via the water-table, and
- Accumulation of salts in the lower slopes due to the sub-surface, lateral or sideways drainage of the soils further upslope. This is a natural phenomenon and is to be expected in any irrigation scheme, in particular where there has been inadequate provision of soil drainage

Salinisation is happening from the sea plus from the land and, for the worst affected areas, there is probably no way to reclaim the land and land-use should probably be changed to construction of fish ponds.

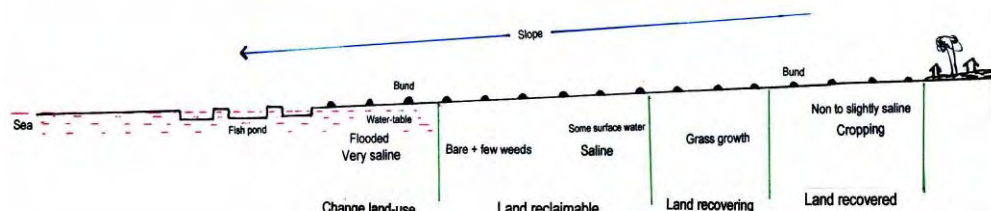
Cross section from village on high ground down-slope through padi area

This scenario is found mainly in Bireuen plus other places where there are large, well established irrigation systems. Cropping has re-commenced in these areas and the combination of irrigation and even minimal drainage has lead to leaching of the salts and reclamation of the land. Farmers are monitoring the recovery themselves and start to cultivate when there is strong, green growth of natural grasses on their fields.

The situation of this scenario is depicted on the right hand side of the diagram where the lower captions read “land recovered” and “Land recovering”.

Very little intervention is now needed on this scenario but, if there had been a more comprehensive drainage system, this land could have been back in production much sooner.

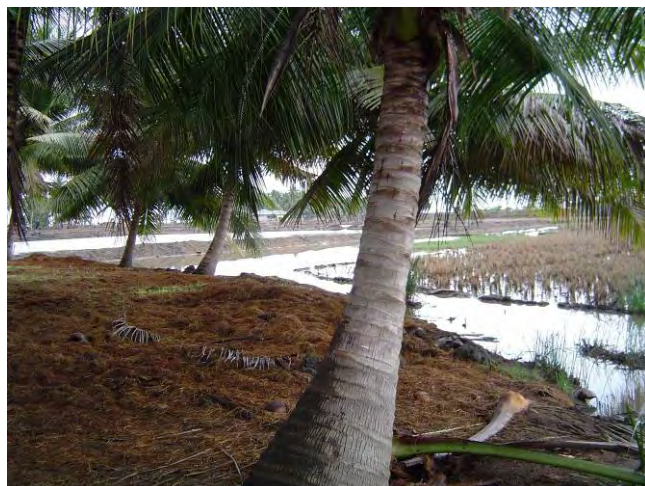
Figure 2.3 Kelapa in Village above Fishponds

Site 6-1 lies on a flat alluvial plain situated just below a slightly raised area with the village and kelapa (Figure 2.3) , next to fishponds, which are close to the ocean. A rice crop had recently been harvested but yield was about 50% of what was obtained pre-tsunami when, the farmer reported, only padi was grown. Cropping was obviously planned again as the field to the left (Figure 2.4) had been puddled whilst the rice stubble can be seen on the right.

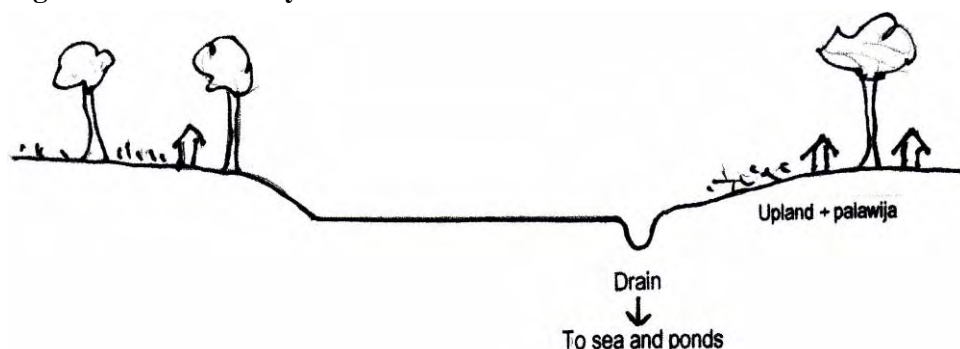
Figure 3.4 Cross Valley Section

Site 5-2, although in the valley from 5-1, is not flooded with no crop since the inundation. However, 200m further up-valley the fields are NOT flooded.

Village settlement on palawija cropping upland areas which are on the sides or edges of the flat alluvial fill or (Figure 3.4).

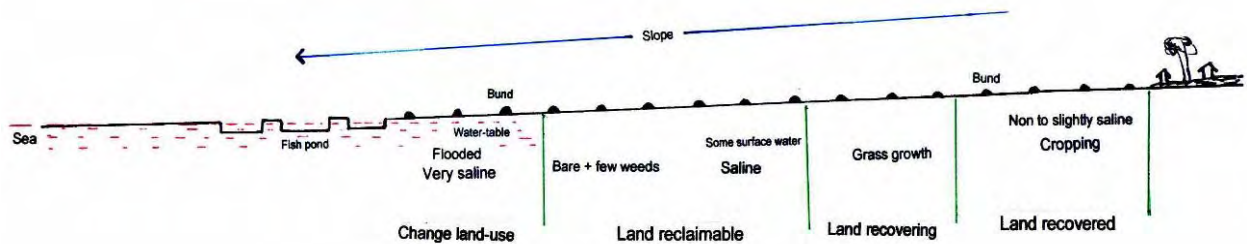
Figure 3.8 Idealised Cross Section from High Ground to Fishponds and the Sea

However, the situation at Cot Leue Rheng is quite different and, although the salinity has fallen a great deal the levels at Site 5-1 are still well above acceptable levels for agriculture. This situation is recognized as ETSEP Scenario 4.

This area has an operational water supply system and some basic drainage channels – though what the farmers call drainage is really overflow systems that remove excess irrigation water from one irrigated field to the next field down-slope. However, there is a large drainage channel running directly down-slope at the opposite side of the field from the inlet for the irrigation water, hence there is some drainage of the land.

There is a progression of salinity increase down-slope with the soils at the top of the slope already back in production (ETESP Scenario 5) and the soils at the lowest points being badly flooded and very saline. There are at least two possible reasons for the salinity of these lower slope sites:

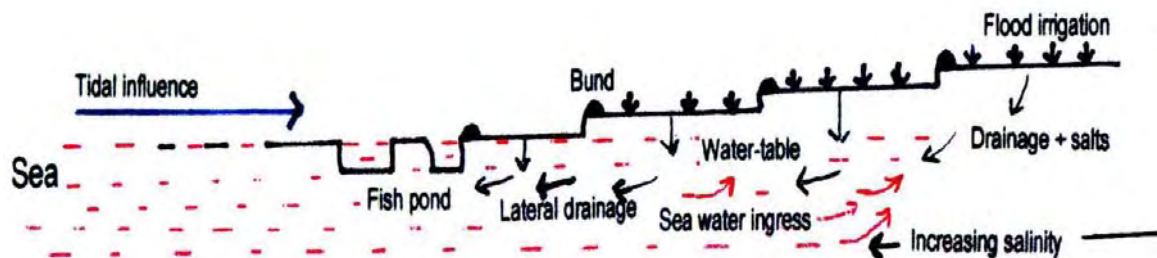
Figure 3.9 Salinisation of Low Lying Site from the Sea and Irrigation

Salinisation is happening from the sea plus from the land and, for the worst affected areas, there is probably no way to reclaim the land and land-use should probably be changed to construction of fish ponds.

A decision has to be made as to where the land-use should be changed to construction of fish-ponds and where reclamation should be carried out. Indicators or guidelines should be the severity of the flooding on the surface, soil and surface water salinity and, also, if there is tidal influence – that is, does the flood increase and decrease with the tide? If there is obvious tidal influence then the land-use should be changed and if the other indicators are present then serious thought should be given to a Landuse change.

Where there is no tidal influence, but the land still be flooded, then the drainage should be increased immediately – this can be done by installing drainage ditches across the slope (on the contour) and ensuring any drainage collected is discharged into the collector drain down the edge (down-slope) of the irrigated area leading to the fish ponds and the sea.

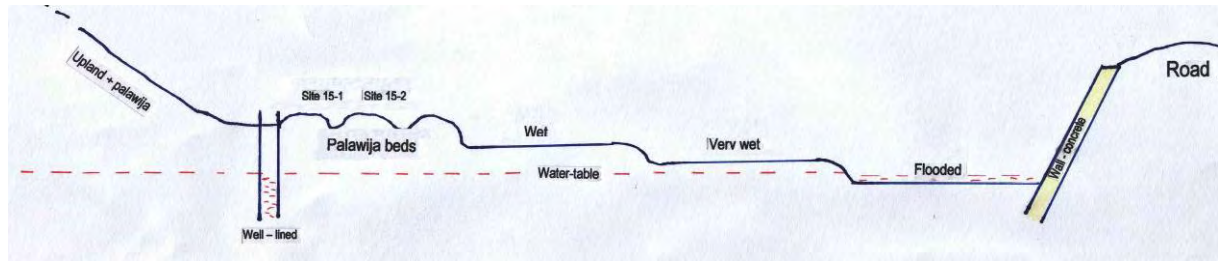
Figure 4.6 Cross Section of a Typical Scenario 1 Location

As an interim measure to allow the farmer re-establish his farm and livelihood, salt tolerant varieties of rice could be grown quite successfully on this site. Dry land cropping is just not possible, as an acceptable root zone of about 60cm needs to be established before palawija can be considered.

6. High water table which gets closer to the surface as the level of the land falls towards the natural stream lines
7. The land in the lower-slope positions is flooded since the water table is actually at the surface
8. Man-made structures, such as roads, urban and agricultural drainage ditches and irrigation channels, acting as dams and blocking the drainage
9. No or poor in-field or on-farm drainage and natural stream lines are no longer active resulting in any accumulated surface or drainage water cannot be removed from the site

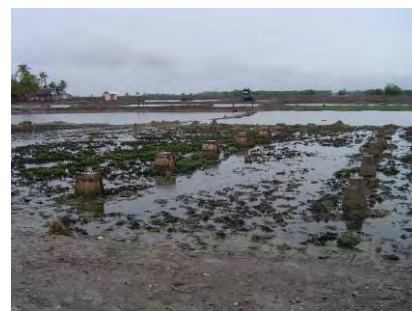
Figure 5.4 Fishponds Site 3-1

Site 3-1 at Cot Jaja (Tungoe was not the correct name as noted during the EM38 survey) was at the edge of the village on a virtually flat alluvial plain and was adjacent to fish ponds very close to the coast. There was an irrigation system but no drainage system for the site. Standing water covered about 60% of the surface and this water was very saline at 15.6mS/cm. pre-tsunami this site was favoured for padi but currently, and since the inundation, cropping is not possible.

Reclamation leaching or, more likely, a change in land use is required at Site 1 in Seukee and Site 3 in Jaja whilst Site 2-1 might be suitable for reclamation due to the much lower salinity. These sites probably all fit the ETESP Scenario 4 situation and the increasing salinities are probably coming mainly from tidal effects and sub-soil sea-water intrusion as depicted in Figure 5.6.

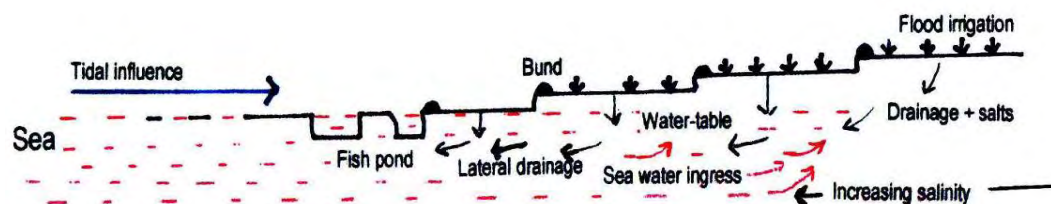
Figure 5.6 Salinisation of low lying site from the sea and irrigation

Salinisation is most likely coming from the tidal effects from the sea and sub-surface ingress. For the worst affected areas, there is probably no way to reclaim the land and land-use should be changed to construction of fish ponds. Accumulation of salts in lower slope positions can be due to the sub-surface, lateral or sideways drainage of the soils further upslope, but the connection at these sites was not too obvious. This lateral drainage is a natural phenomenon and is to be expected in most low-lying sites, in particular where there has been inadequate provision of soil drainage to intercept and remove the lateral flow. However, the existing salinity, whether it is high or low, whether it exists at the surface (0–30cm) or in the subsoil (60+cm) layers, will NOT go away or reduce if:

- the sites do not have an operational drainage system to remove the saline water and leachate from the site once reclamation is started
- new saline water enters the site, whether this is from tidal effects, sea-water ingress through the subsoil or carried in the drainage from sites higher up the valley
