EARTHQUAKE and TSUNAMI EMERGENCY SUPPORT PROJECT (ETESP)

RED CROSS SITE – LAMBADEUK, ACEH BESAR

(March 2006)

VISIT TO RED CROSS SITE LAMBADEUK WEST OF BANDA ACEH

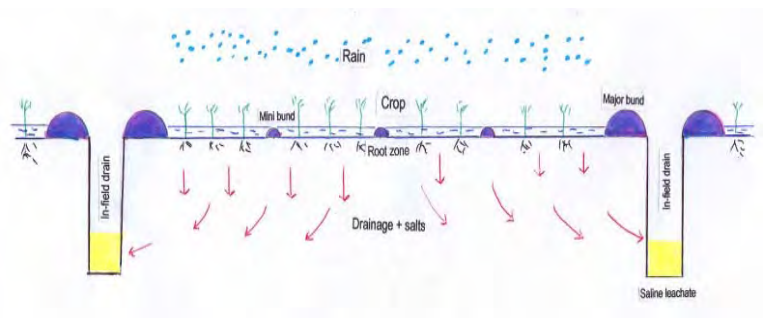
Figure 2.5 In-field Drains Cross Section

There was no obvious existing in-field drainage system seen though at one point on the lower edge of the site a remnant drain was identified.

In-field drains have to have bunds installed along their length to prevent surface water (rainfall or irrigation) from flowing directly into the drain instead of infiltrating into the soil.

No more concreting should be done but what has been constructed should remain in place but field edge bunds must be constructed (Figure 2.5) to ensure that any water that does enter the field is allowed to infiltrate and not immediately drain away by flowing directly into the drain.
