EARTHQUAKE and TSUNAMI EMERGENCY SUPPORT PROJECT (ETESP)

Field Tour Report

Feb 20th – Feb 24th 2006

(Version of 6 March 2006)

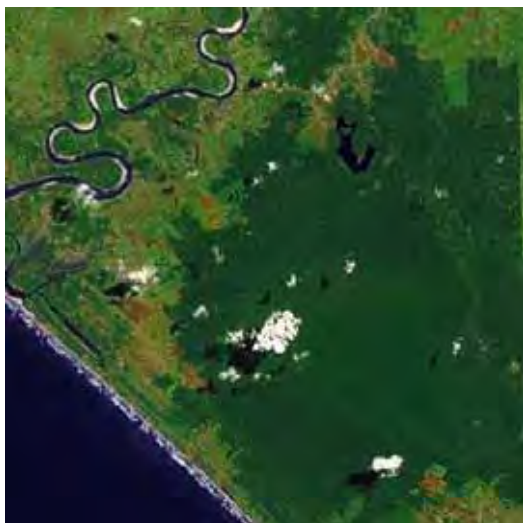
Figure 3.1 Peat Area

About 2hrs 30 min south of Jabi there was a huge area cleared in the forest for a new desa – this is in a peat area.

In the Landsat images above the peat area is the uniform dark green forested area with very few obvious signs of any development within it, apart from the faint line in Figure 3.1 which would be a road – but it is not known if this is the alignment of the new road. Soon after that normal mineral soils occur and villages had normal dry-land farming with many coconut trees; the change from peat to mineral soil area is very clear in Figure 3.2. Suak Geudebang was then reached in 3hrs 20 min where the new housing was more traditional in design and of wood construction. Two site inspections were carried out here (Refer Section 4.2)

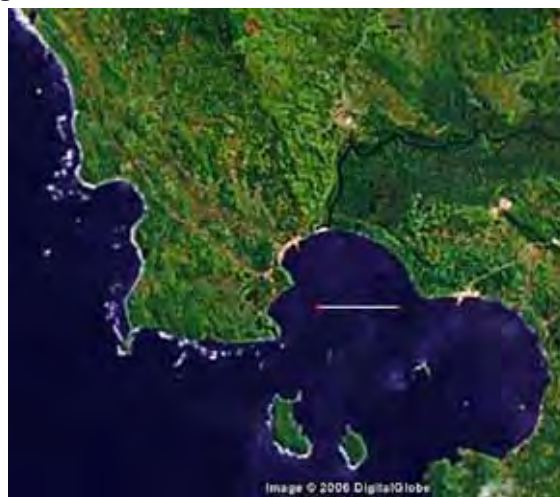
Figure 4.2 Jabi Site on LandSat

Damage: classified on the ISRI (Bogor 2005) maps as heavily damaged due to salinity level and depth of sediment.

However, since this area was presently totally covered in very vigorous, mixed vegetation and the surface showed a texture of fine sandy clay loam ETESP would not accept this as heavily damaged land.

The vegetative state suggests that the salinity is not presently a problem and the texture is a perfectly suitable medium for plant growth (Refer Sandy Sediments, ETESP, 2006) and in the LandSat image there are no patterns to suggest problem soils.

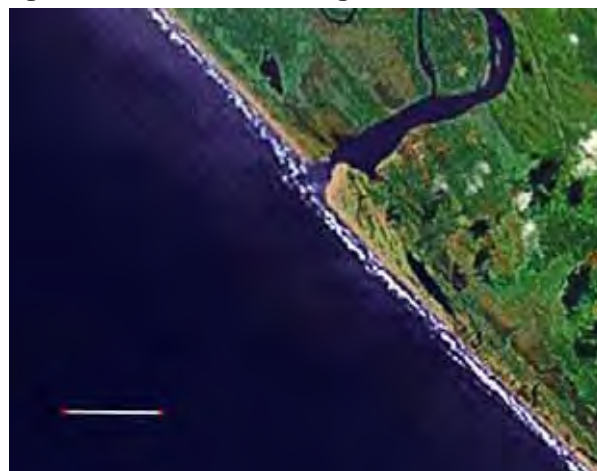
Figure 4.4 Suak Geudebang on LandSat

Damage: although badly flooded this site could only be described as lightly damaged in that there is now strong, mixed local vegetative growth and no flooding seems to presently exist. Topsoil texture could not be checked due to the density of vegetative cover but it seemed to be dark coloured and might possibly be peaty

It is not easy to reconcile the topo-map with the LandSat image and it is assumed that the river course and shape has changed near the coastline.

Conclusions: this area would seemingly be relatively easy to clear and recover with the main problem being disposal of the excessive amount of local vegetation now covering the site. There would be too much to contemplate composting and burning would appear to be the only option

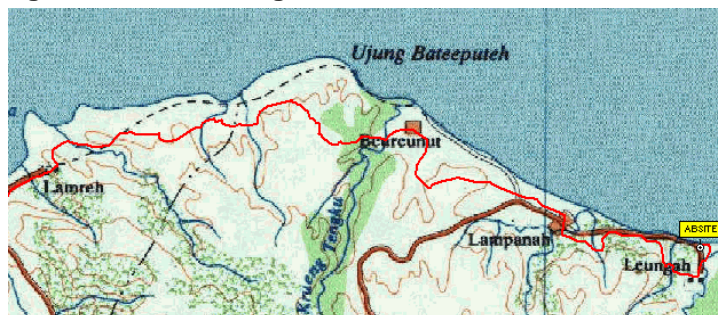
Figure 4.6 Desa Leungah

The GPS road track on the map, in red, can be seen on the LandSat image as a pale coloured line – otherwise it is not easy to reconcile the map with the image.

tide. The local population continues to live in their original houses and there are no obvious signs of the tsunami having caused much in the way of physical damage.

Damage: as noted above there are no obvious signs of the normal, devastating damage inflicted on villages this close to the shore line; a possible explanation for this being suggested above below Figure 4.4. The flood was relatively gentle and about one metre deep and it did retreat very quickly. Damage would have been limited to salinity caused by the infiltration of the sea water.
